Structural Engineering Inspection Report

79 Chinbrook Road, London SE12 9QL

Project No. 9360

13 April 2016

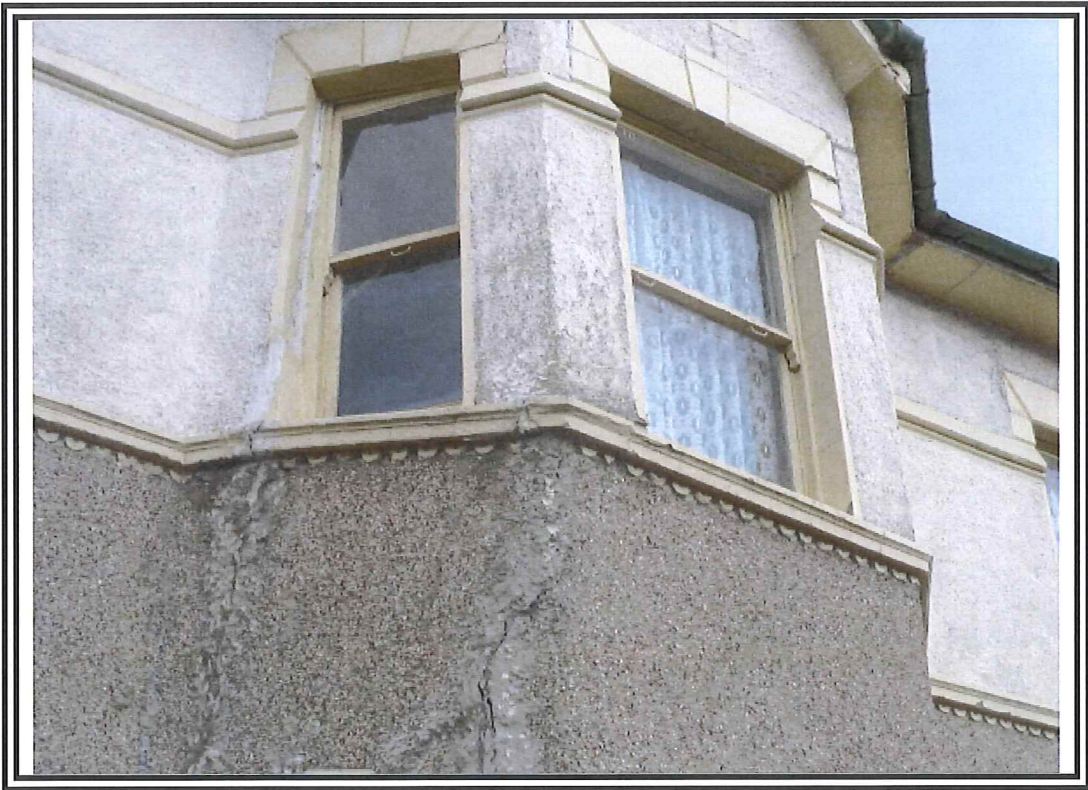
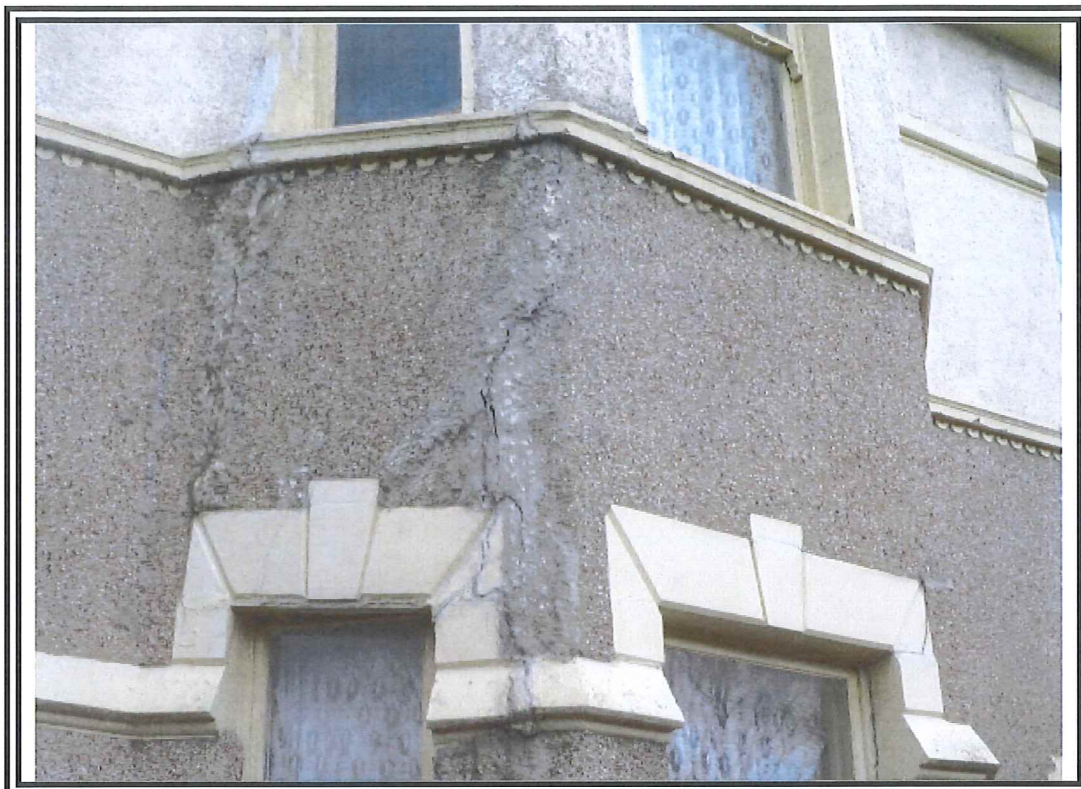
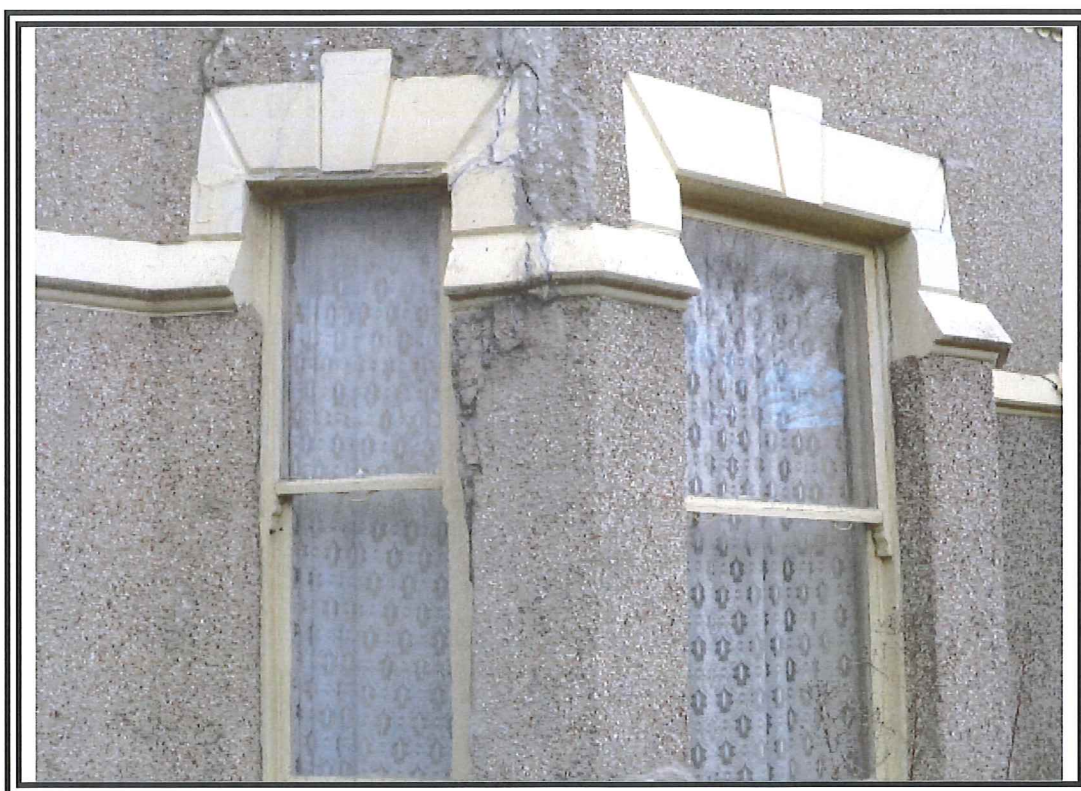
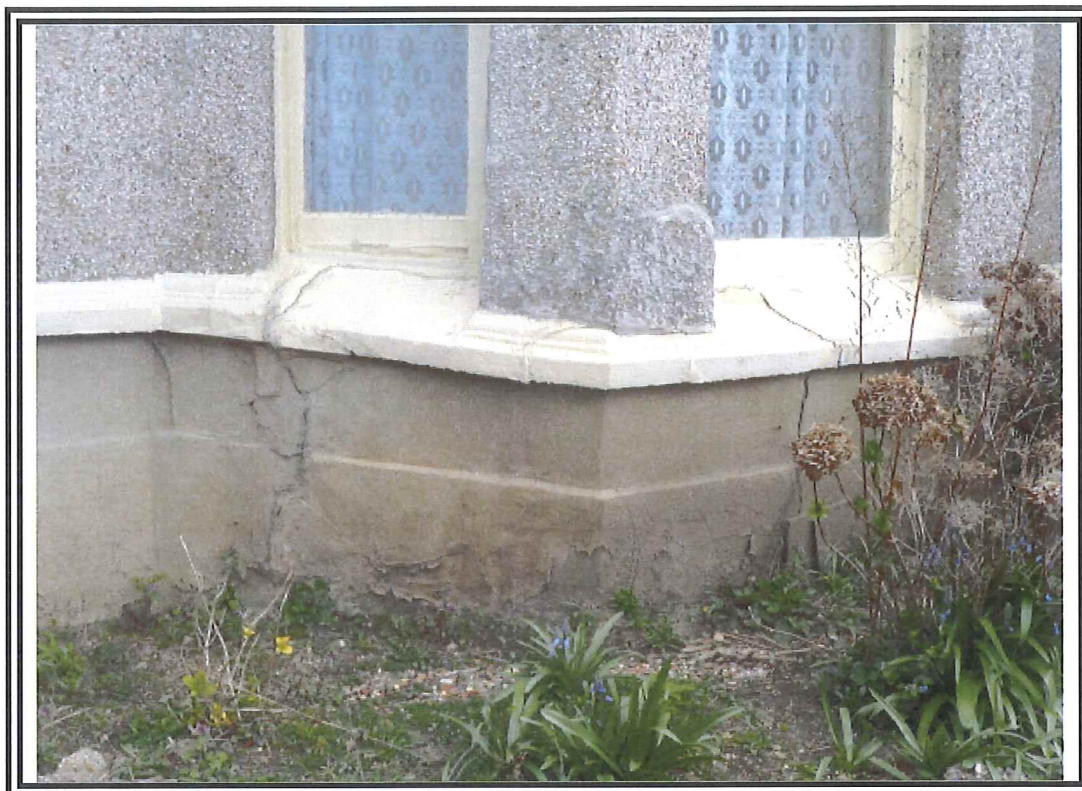
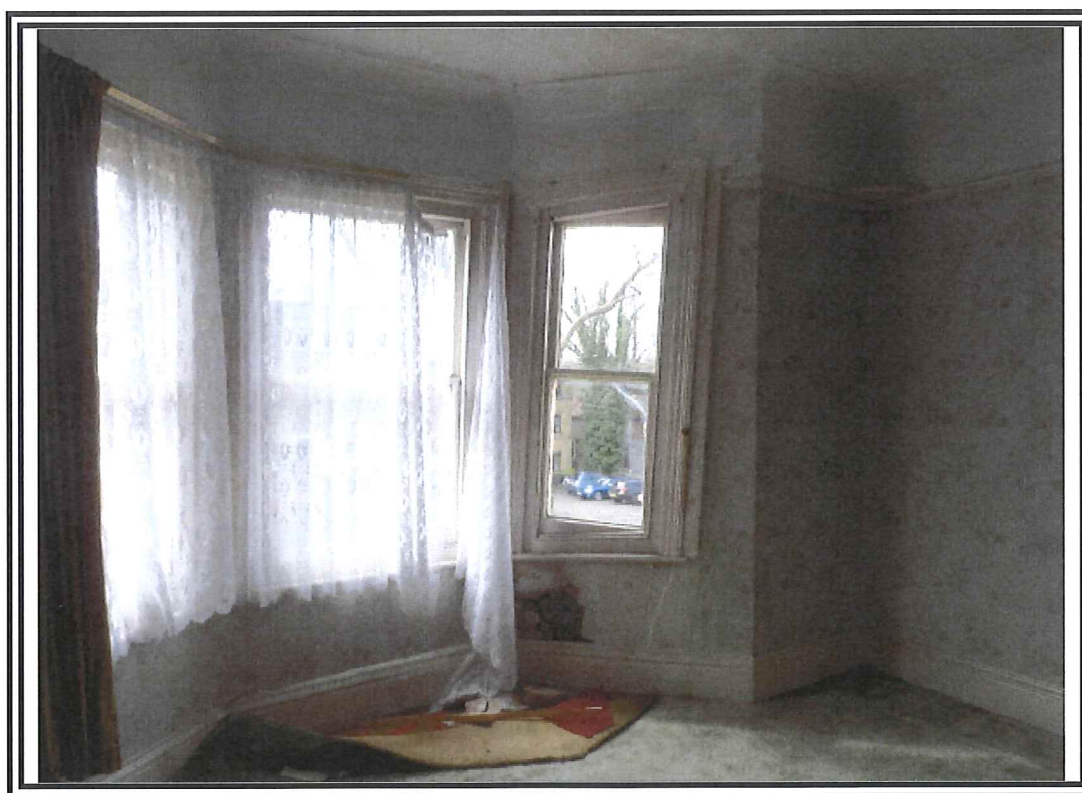
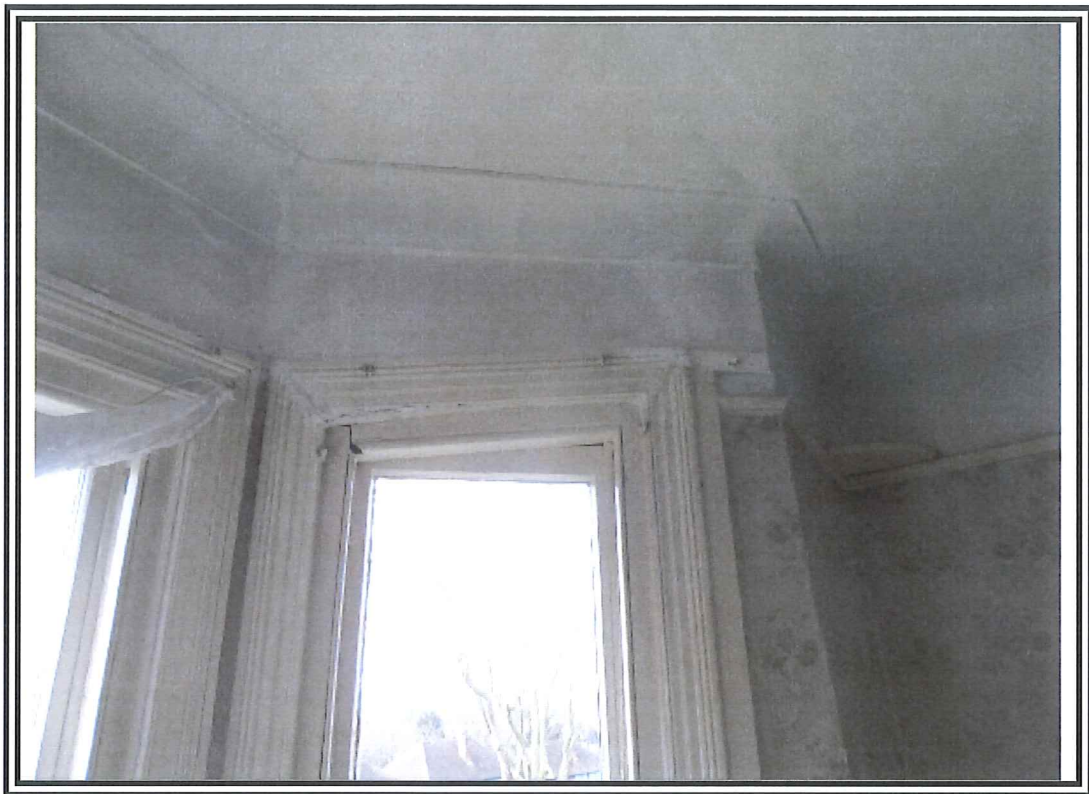
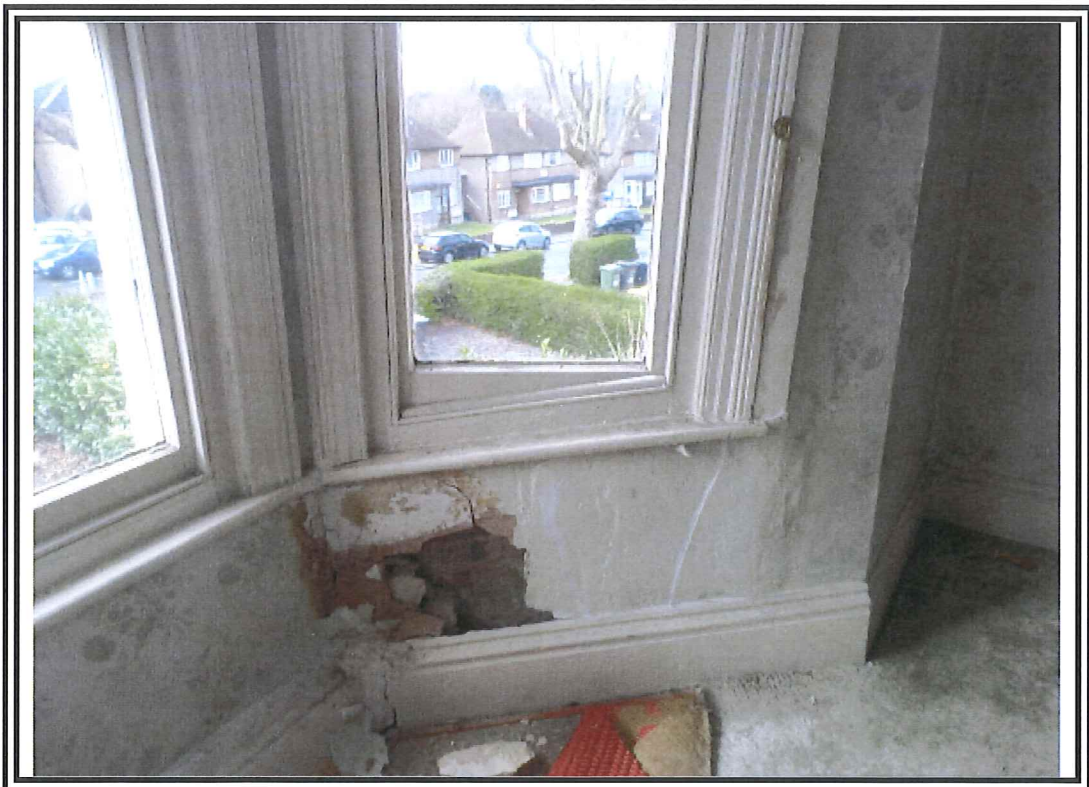
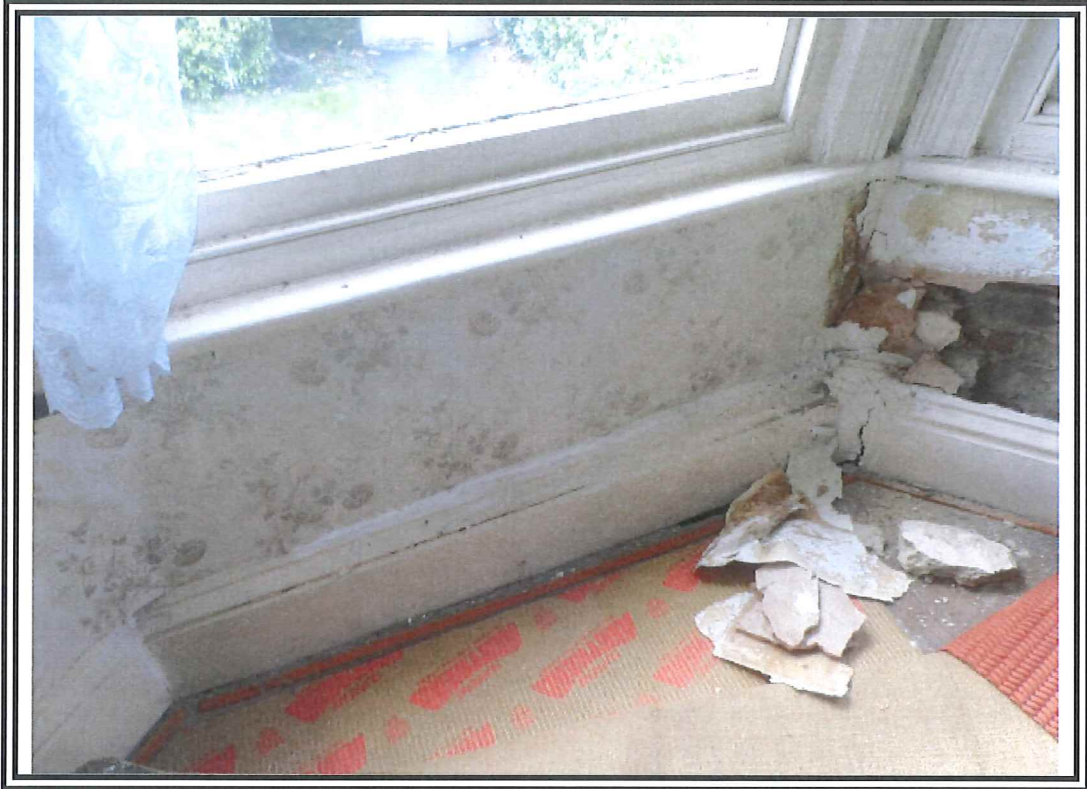
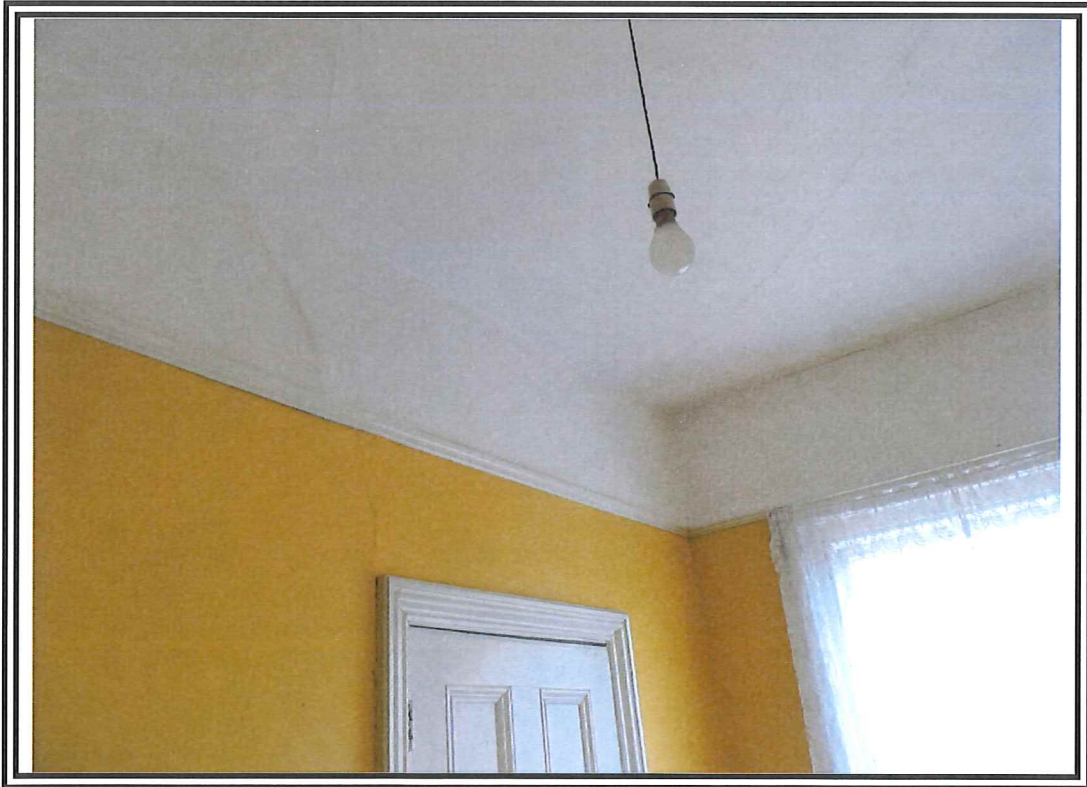
- 3.3 The bay window construction to the left hand side of the front elevation has been subject to significant movement. Large cracks have developed within the masonry walls

- for the full height. At first floor level, lateral movement of up to 50mm was noted to the masonry structure. See photographs 5-13.
- 3.4 Cosmetic repairs have been undertaken to the cracks in the past and the timber window framing adapted to suit the movement of the masonry walls.

4.3 The movement at the left hand bay window structure is significant and the repairs to the cracking and decorations and adaptation of the window frames suggest that this has been ongoing for some time, possibly since original construction.

- 4.11 As a minimum, we would anticipate that remedial works required would include,
- Demolition and rebuilding of the left hand bay window from a new, sound foundation built from a competent bearing stratum.

- 5.3 The left hand bay window structure has been subject to significant movement that may have been occurring since original construction. This should be taken down and rebuilt from a sound foundation on competent soils.

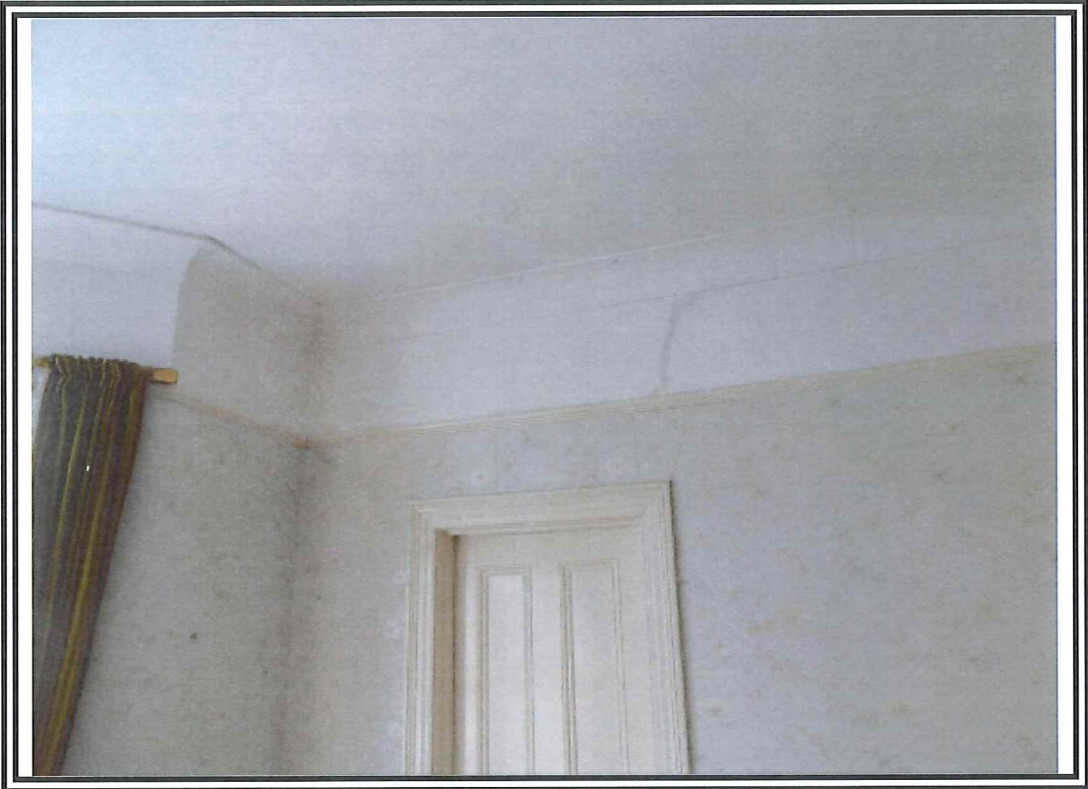
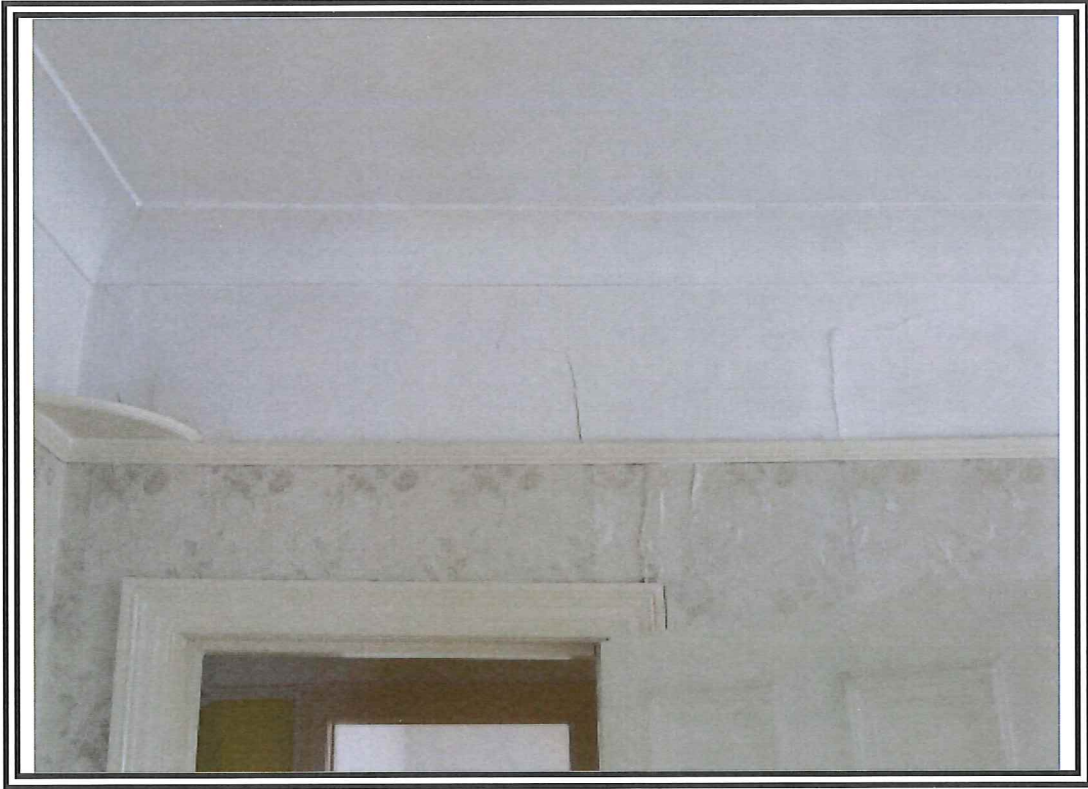
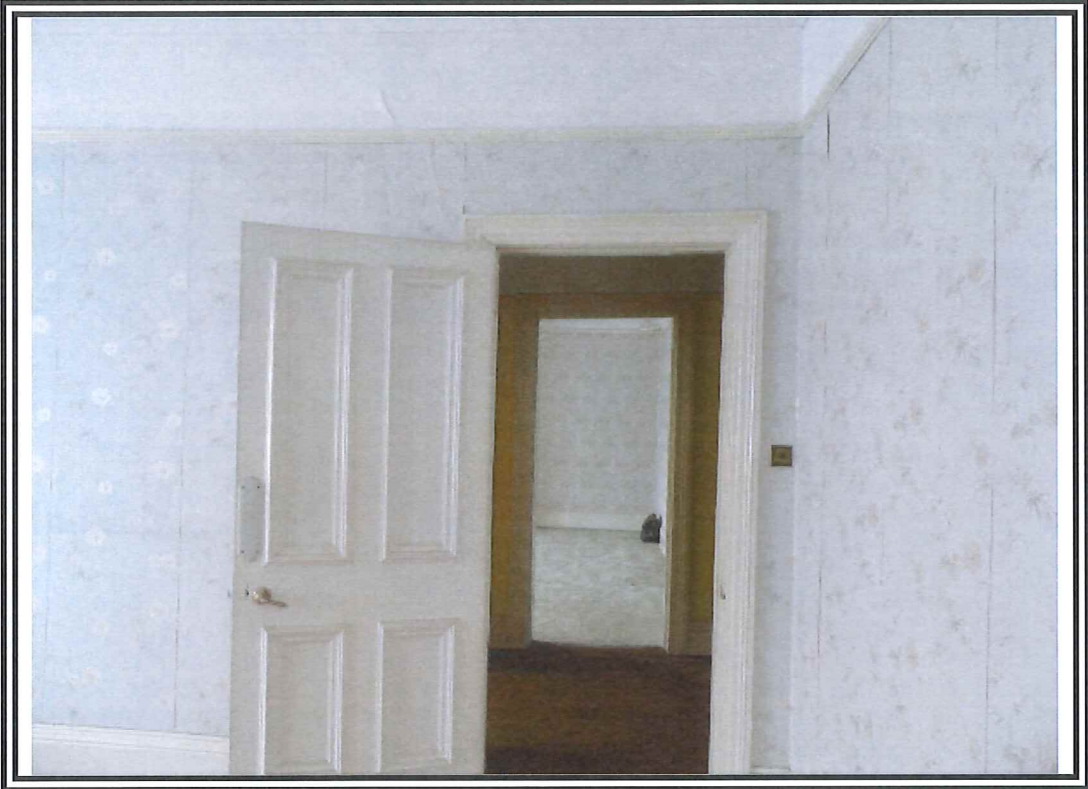
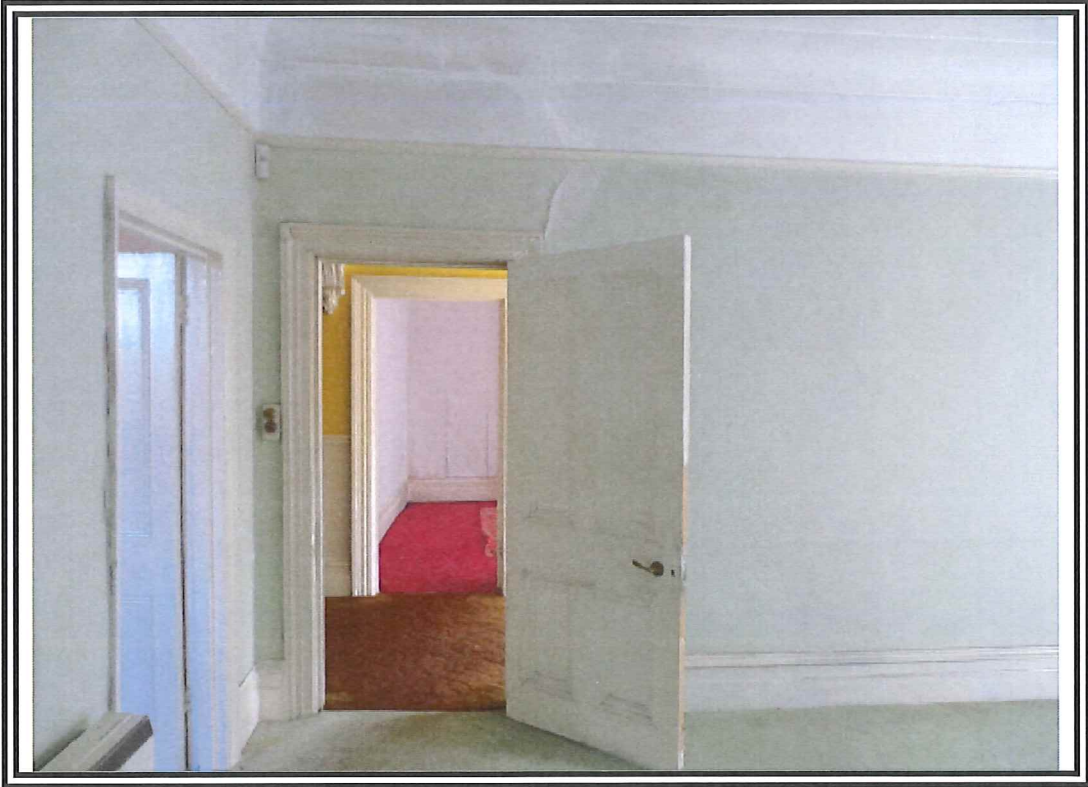
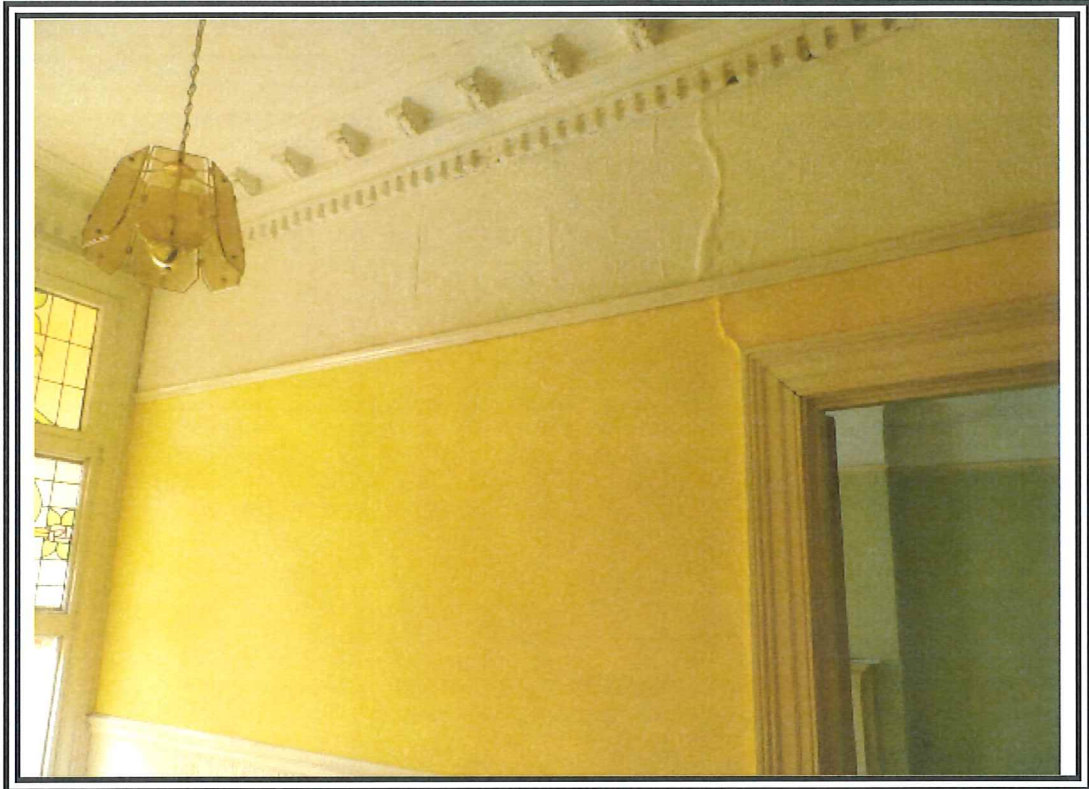
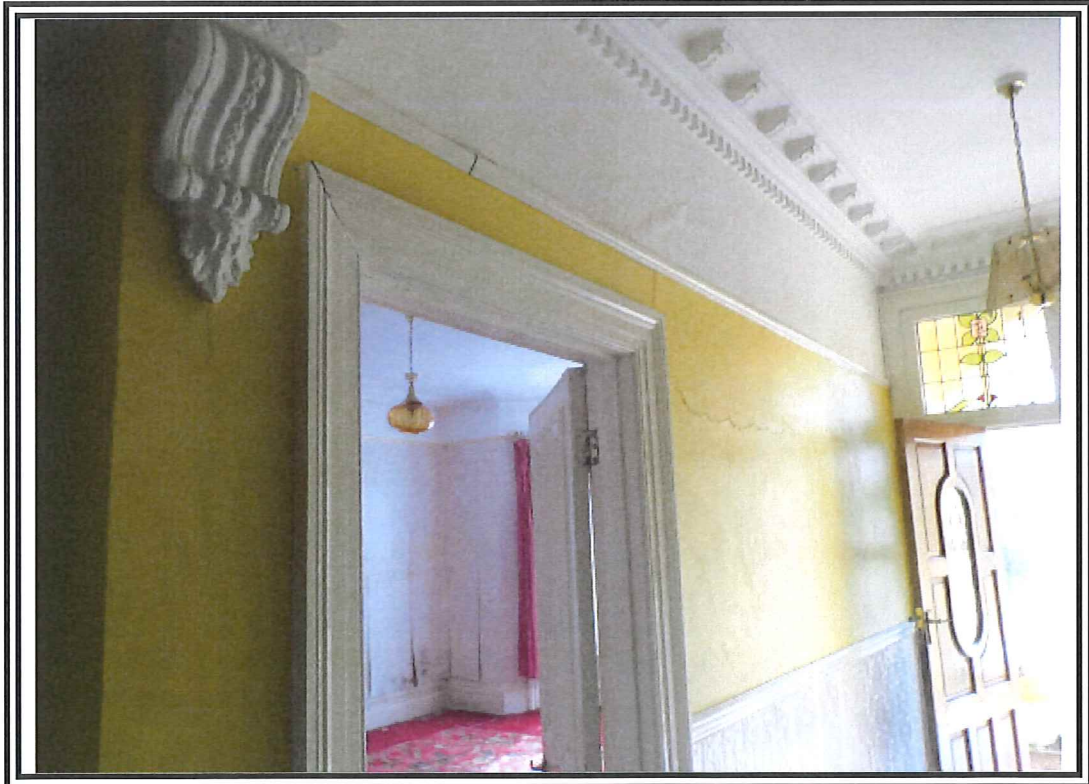
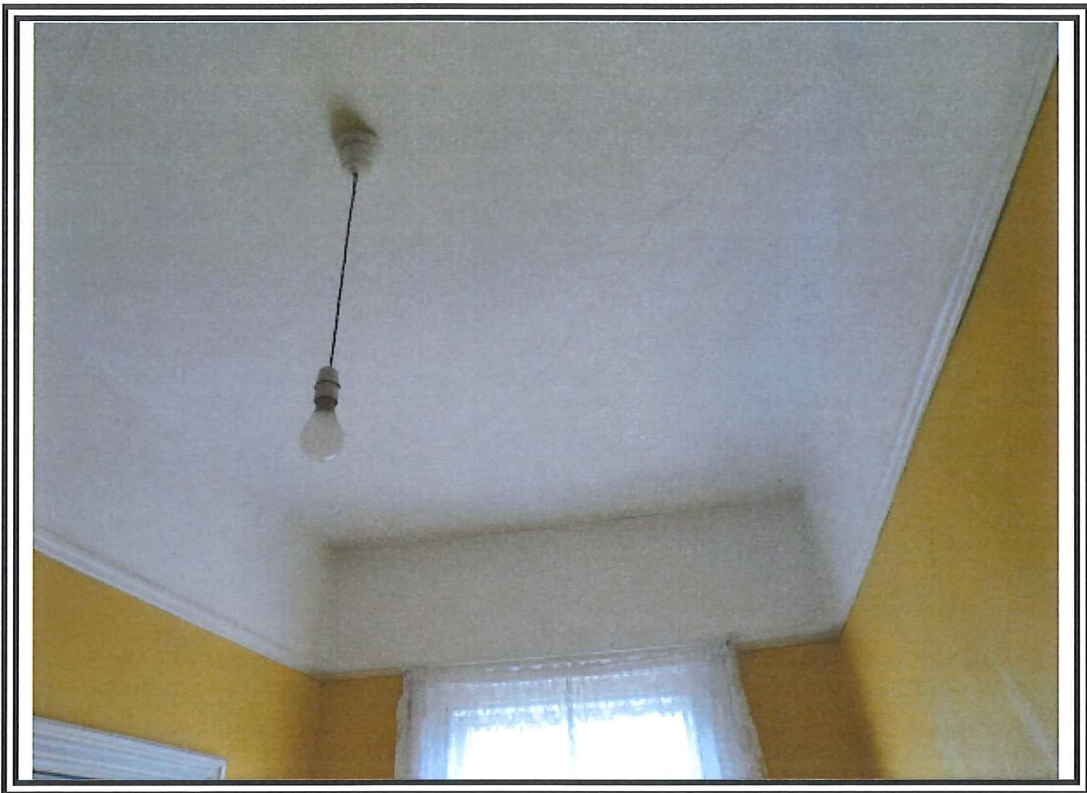
- 3.5 The internal loadbearing walls perpendicular to the front elevation at first floor level have significant diagonal and vertical cracking and the door frames within the walls are not square. Whilst the cracking and distress are most significant at first floor, similar cracking was noted at ground floor, where there is horizontal cracking also. See photographs 14-20.

4.4 The cracking and defects noted to the internal walls are also significant and have been ongoing for some time.

- Underpinning to the internal spine walls on either side of the entrance hall to ensure these are supported by a competent bearing stratum.
 - Provision of safe access into the basement area so that an inspection can be undertaken and any defects noted as these may have a bearing on other areas.

- 5.4 The internal walls, particularly those perpendicular to the front elevation on either side of the entrance hall, have been subject to foundation movement and further investigation would be required to establish the cause of this and confirm remedial works. As a minimum, we would anticipate that underpinning would be required to the walls along with repairs to the cracked masonry.

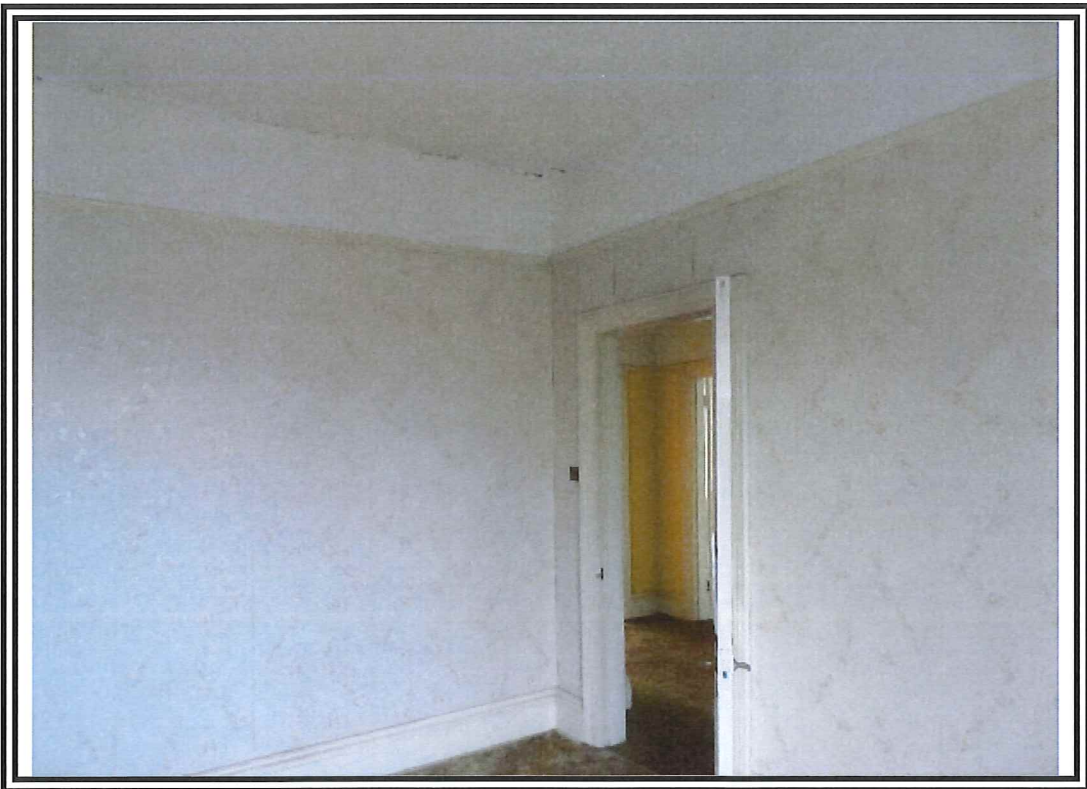
Photo 21:

- 3.6 There is cracking to the ceiling finishes to the underside of the roof at first floor. See photograph 21.
- 3.7 There is tearing to the wall paper within Bedroom 4, where the wall between it and the Master Bedroom meets the ceiling. The floor level appears to fall towards the external wall. See photographs 22-23.

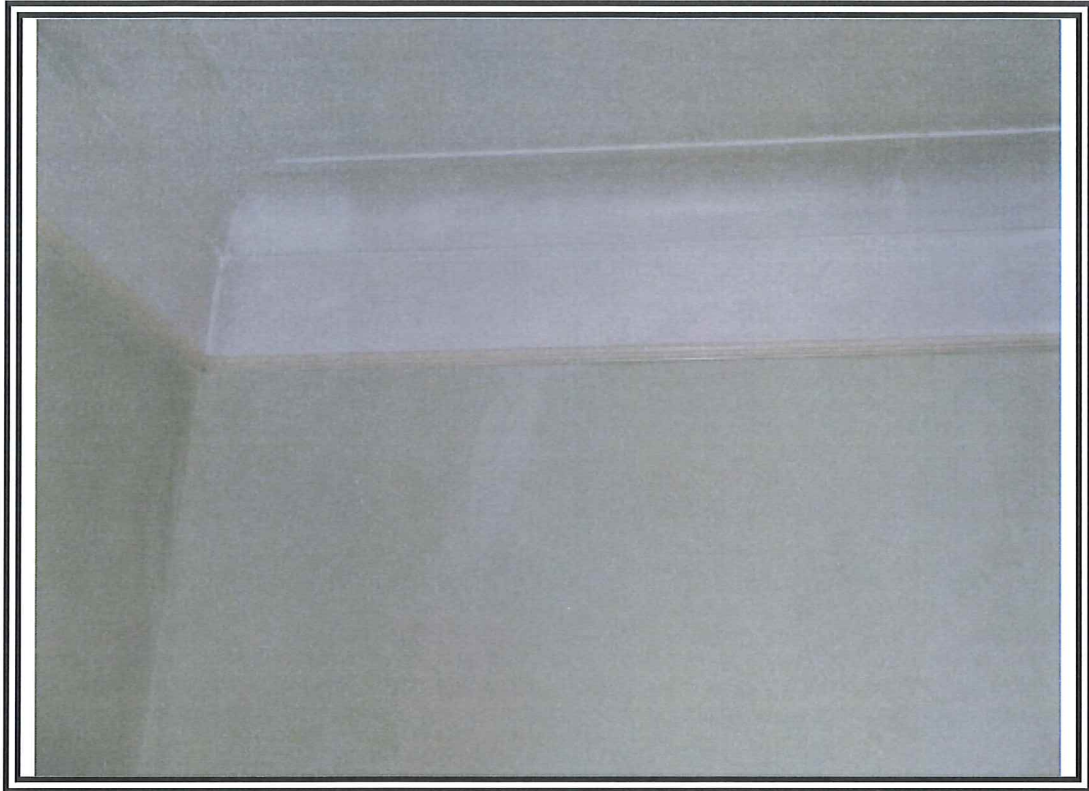
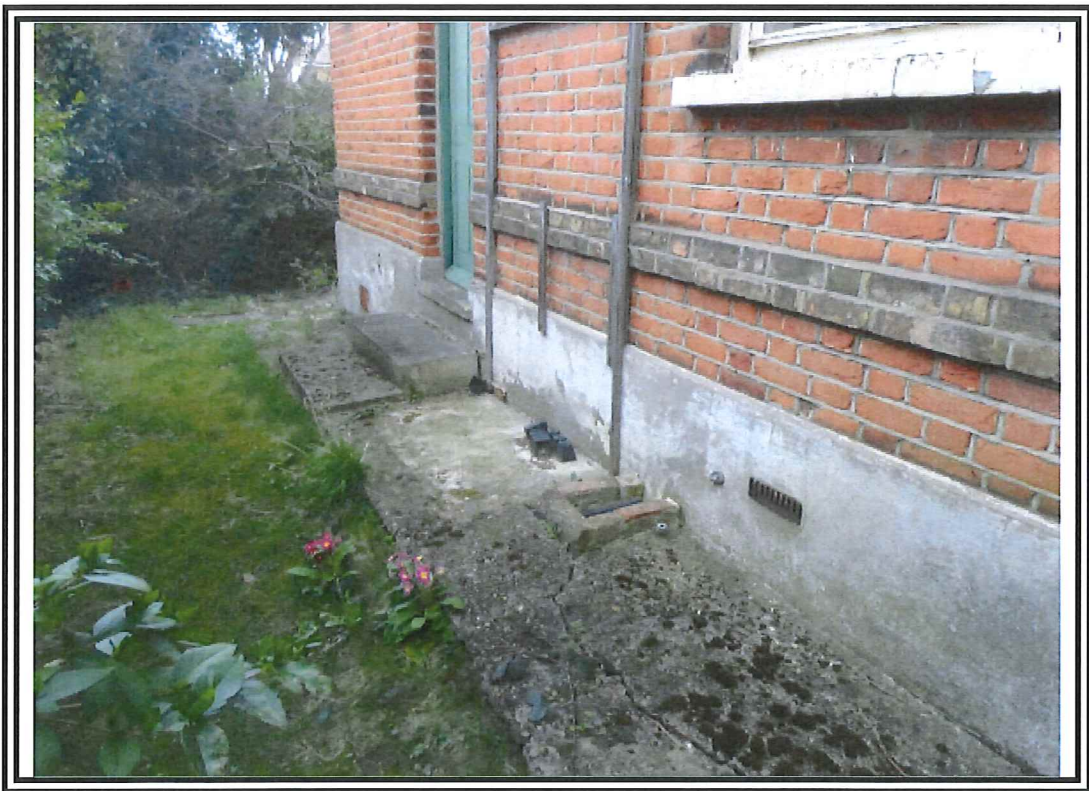
- 3.10 The floor levels to the ground floor reception rooms appears to fall toward the external wall and garage.
- 3.11 Diagonal cracking was noted to the wall between the Dining Room and front reception room where it meets the internal and external walls. See photographs 24-25.

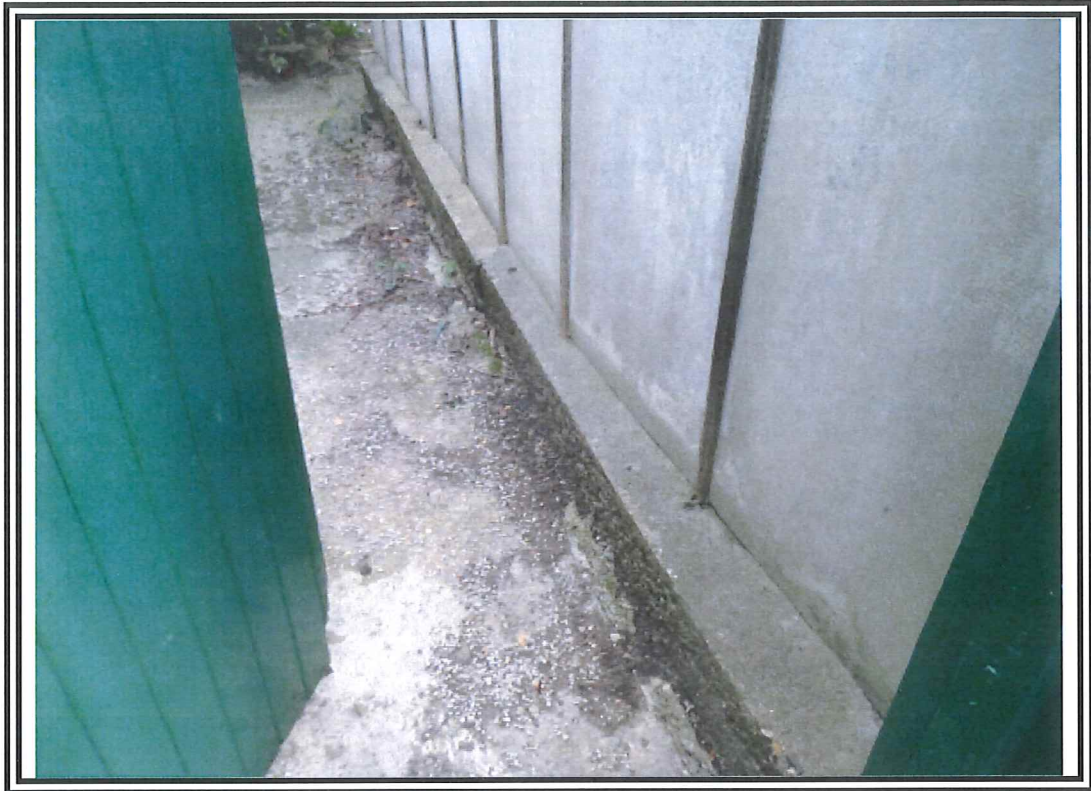
Photo 26:

- 3.12 Externally, movement is apparent to the concrete footpaths to the side and rear of the property. See photograph 26.
- 3.13 Cracking was noted to the external exposed sections of concrete surround to the garage to the left hand side of the property. See photograph 27.
