BROADWAY THEATRE, CATFORD
CONSERVATION MANAGEMENT PLAN
ISSUE 01: FINAL
JULY 2018

BROADWAY THEATRE, CATFORD: CONSERVATION MANAGEMENT PLAN

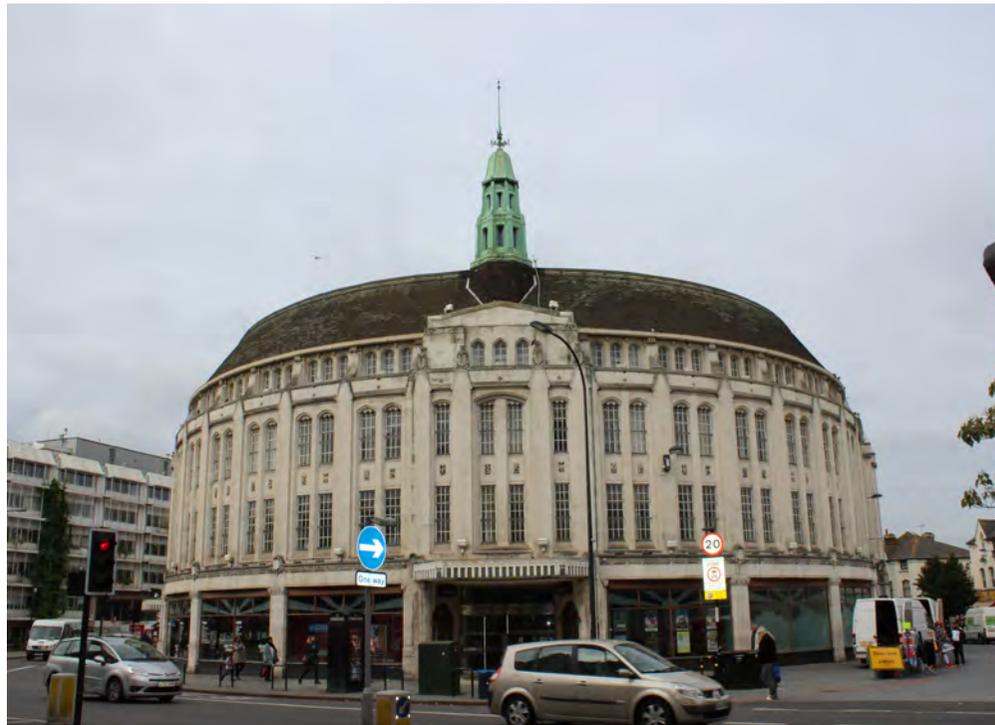
Existing east elevation of the Broadway Theatre

The theatre occupies the curved peninsula in between Catford Road and Catford Broadway and reflects the street layout in a curved stone façade fronting to the north, east and south. To the ground floor there are two entrances into the main body of the theatre building. To the east, the entrance comprises two timber double doors leading to the box office and staff offices with a modern, glazed automatic double door which leads to the Town Hall Chambers. The entrance is sheltered by a canopy decorated with a dentilled fascia. To the south side, the main concert hall entrance comprises four double doors which is sheltered by a flat, rounded canopy stretching over the pavement of Catford Road which is also decorated with a dentilled fascia.

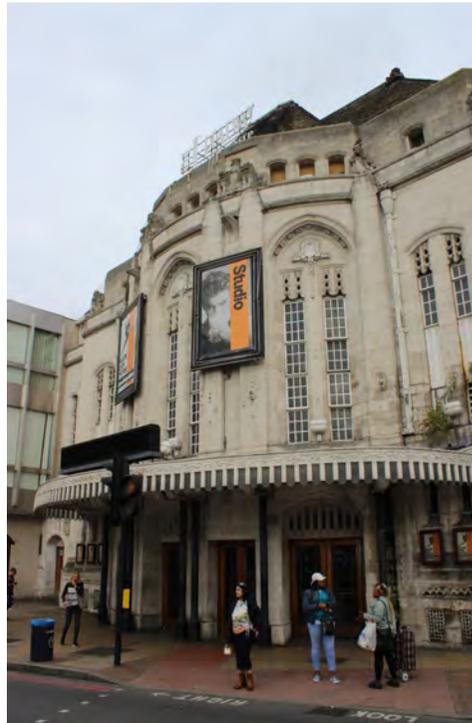
South entrance to the Broadway Theatre

The four-storeyed theatre building is mounted by a steeply pitched, tiled roof with a two-storeyed domed steeple with a weathervane above. To the south, an illuminated sign titled "The Broadway Theatre" reinforces the buildings identity and presence within the town centre.

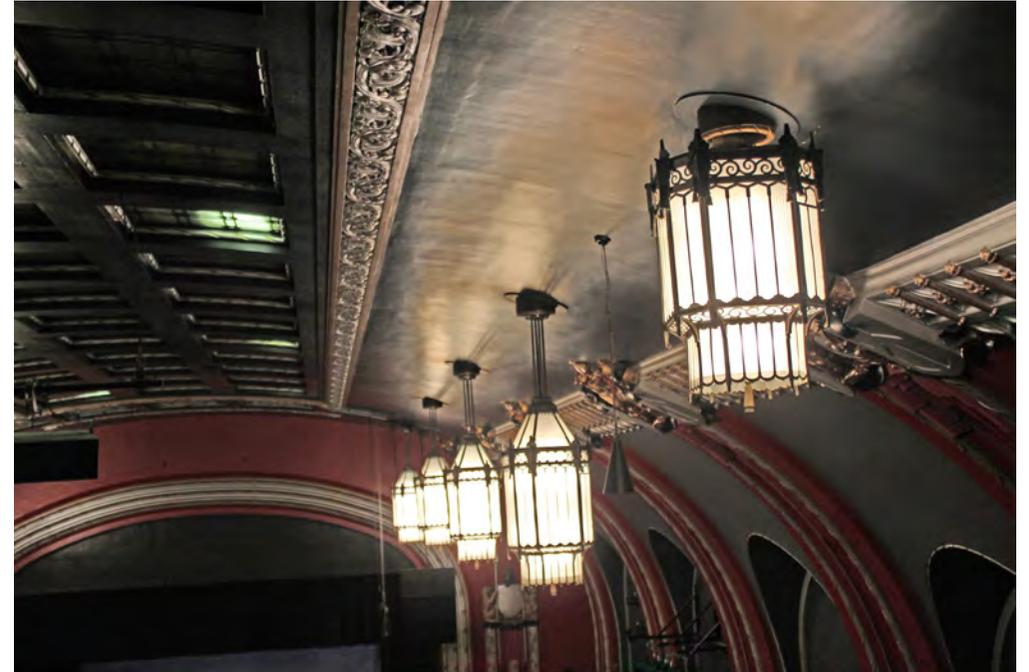
SF2: Photograph of the suspended Art Deco lanterns

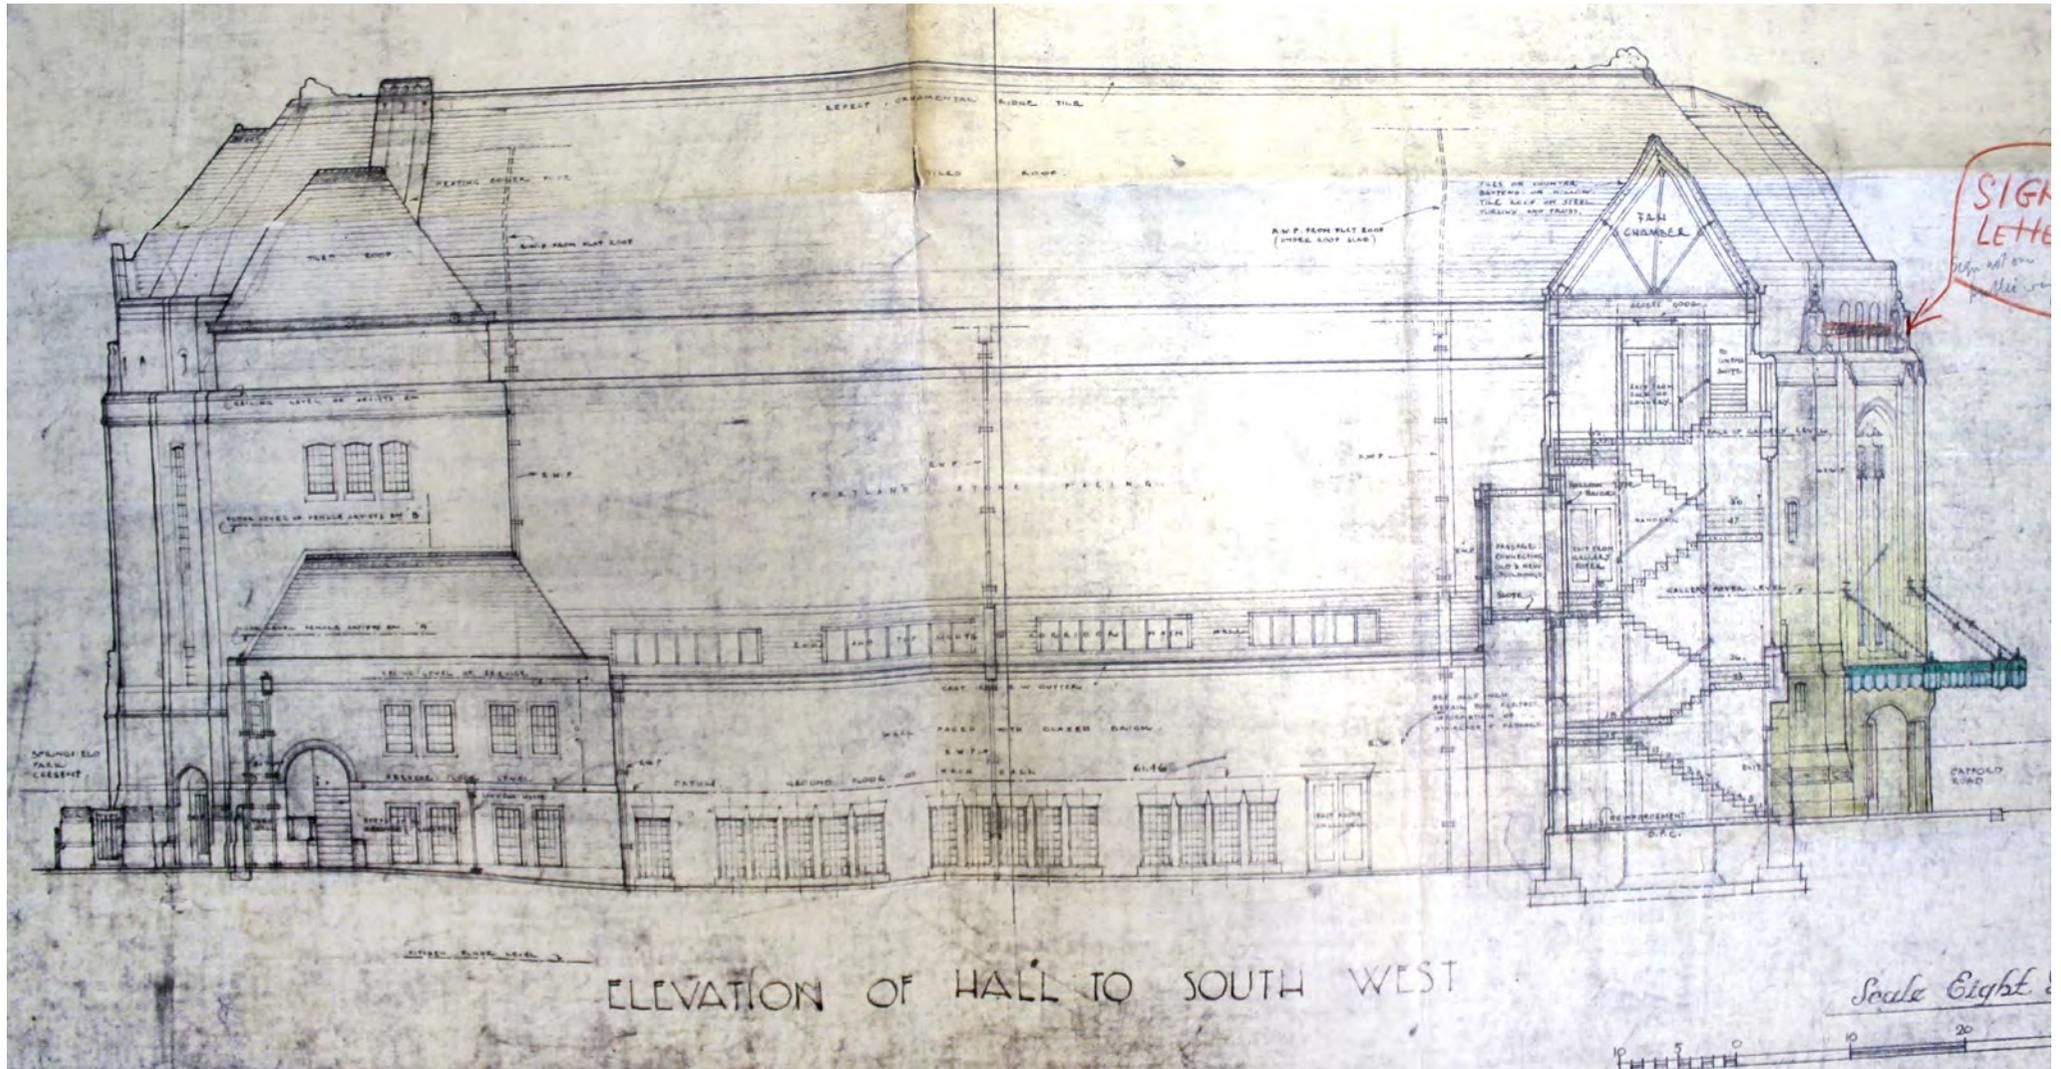
Hopes south-west elevation drawing, 1930

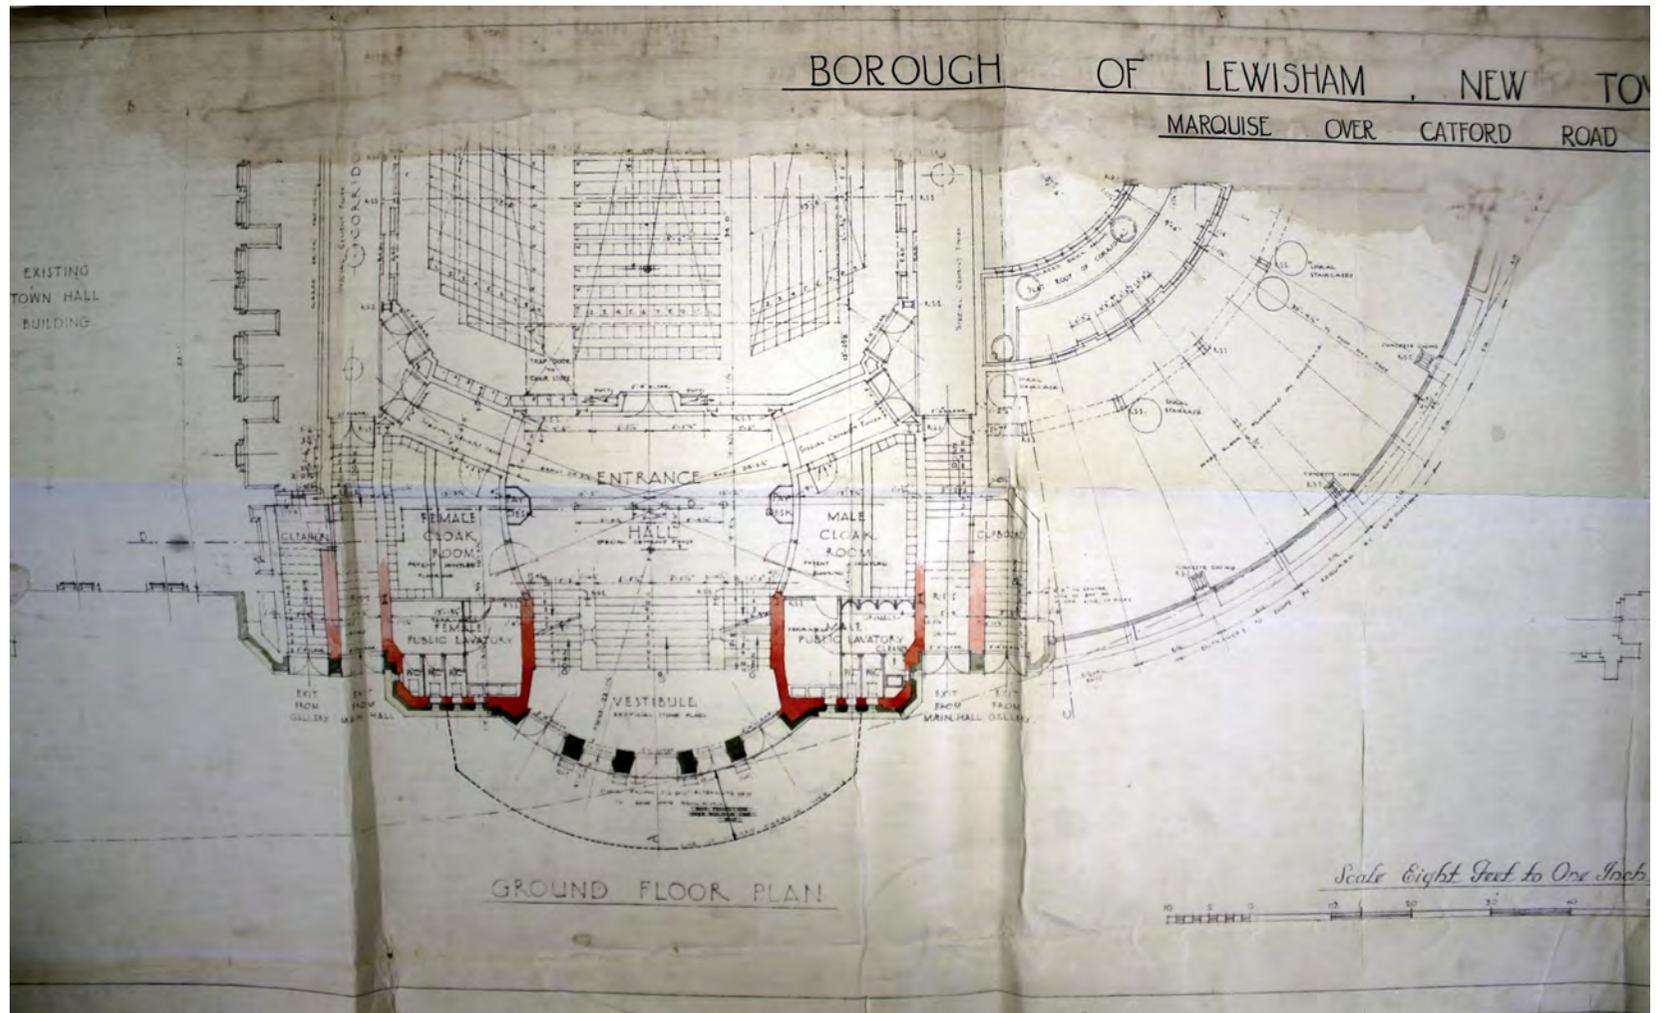
Hope's (partially complete) ground floor plan, 1930

It is clear that Hope's focus remains on the south vestibule entrance which establishes the main public entrance from the street. The plan is largely symmetrical and leads the visitor up the central grand staircases towards the entrance hall which is flanked by public cloakrooms. To the right hand side, Hope designs open plan offices which follow the form of the curved peninsula site externally which is echoed along the internal corridor to the centre.

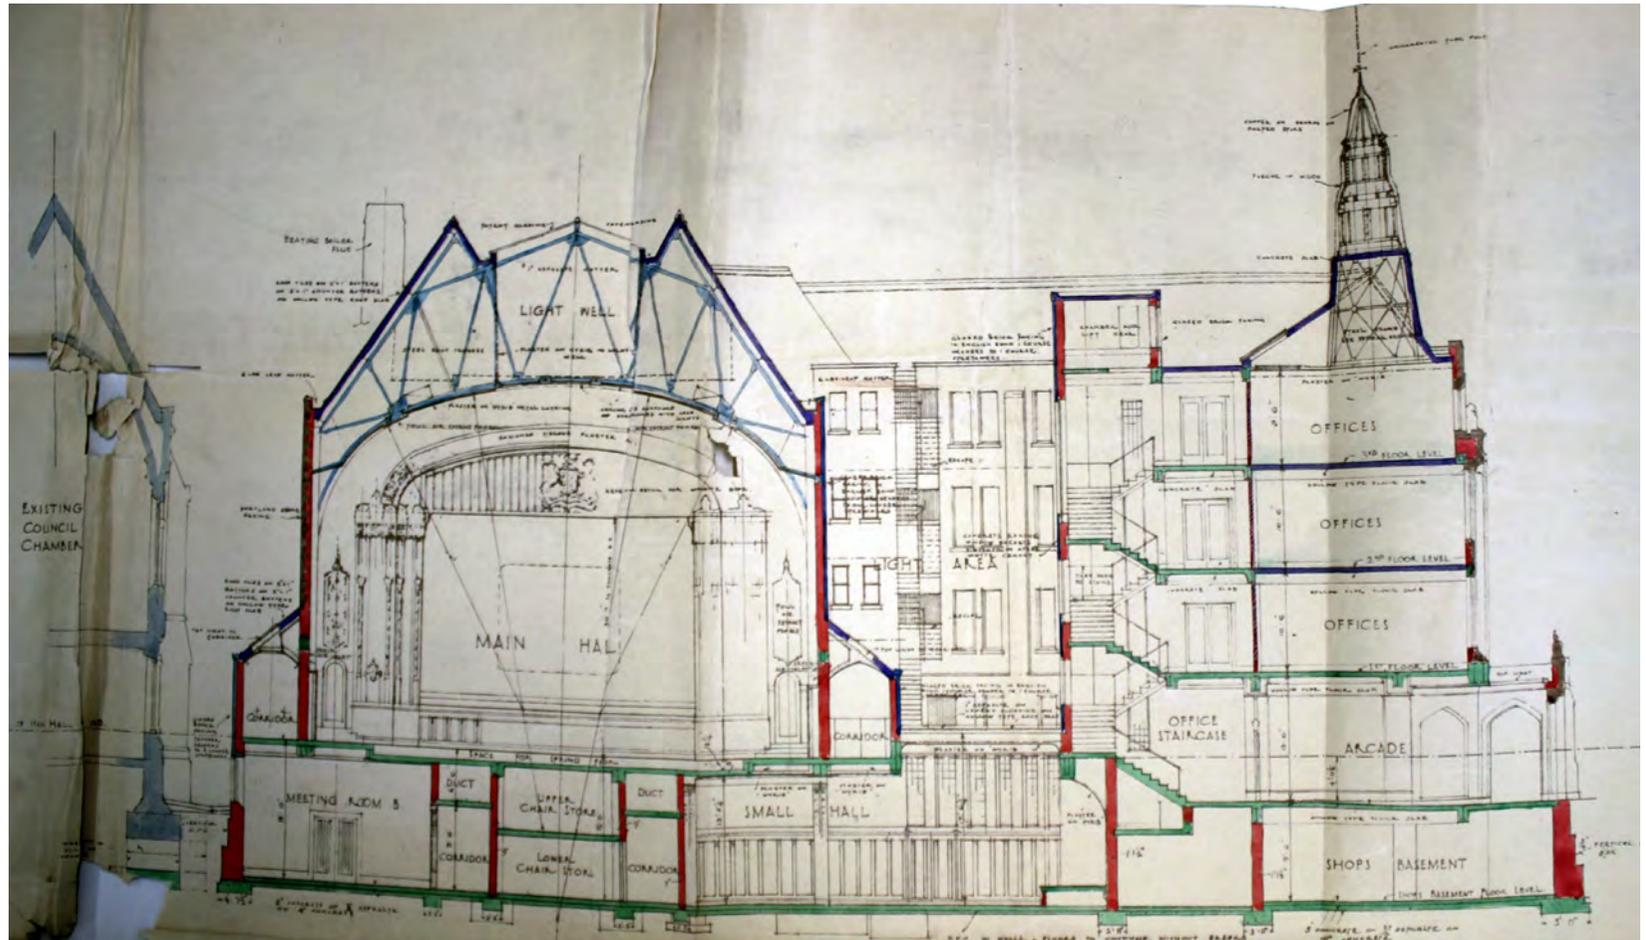
Hope's section through the main hall, 1930

The following selection of drawings are Hope's section plans for the building and show his careful consideration for the separation of functionality inside the building. What is equally noteworthy, however, is the level of connectivity of the key spaces and the rationality of the segregation of the office space and the theatre. The specificity of these drawings, aligns them with the prevalent thinking in the 1930s for the planning of the interior. The three levels of office accommodation are placed together and separated from the Theatre by a centrally-place and top-lit atrium. The lift core and staircase link the floors together and lead to the porch entrance to the east. The Theatre space is supported by rooms and dressing rooms that are accessed from a rear staircase, whilst visitors to the theatre enter and approach the Auditorium through the grand southern entrance foyer areas. Each of these internal functions have their own entrance and exit and circulation routes. The Broadway Theatre was completed by 1932 and was opened shortly after.

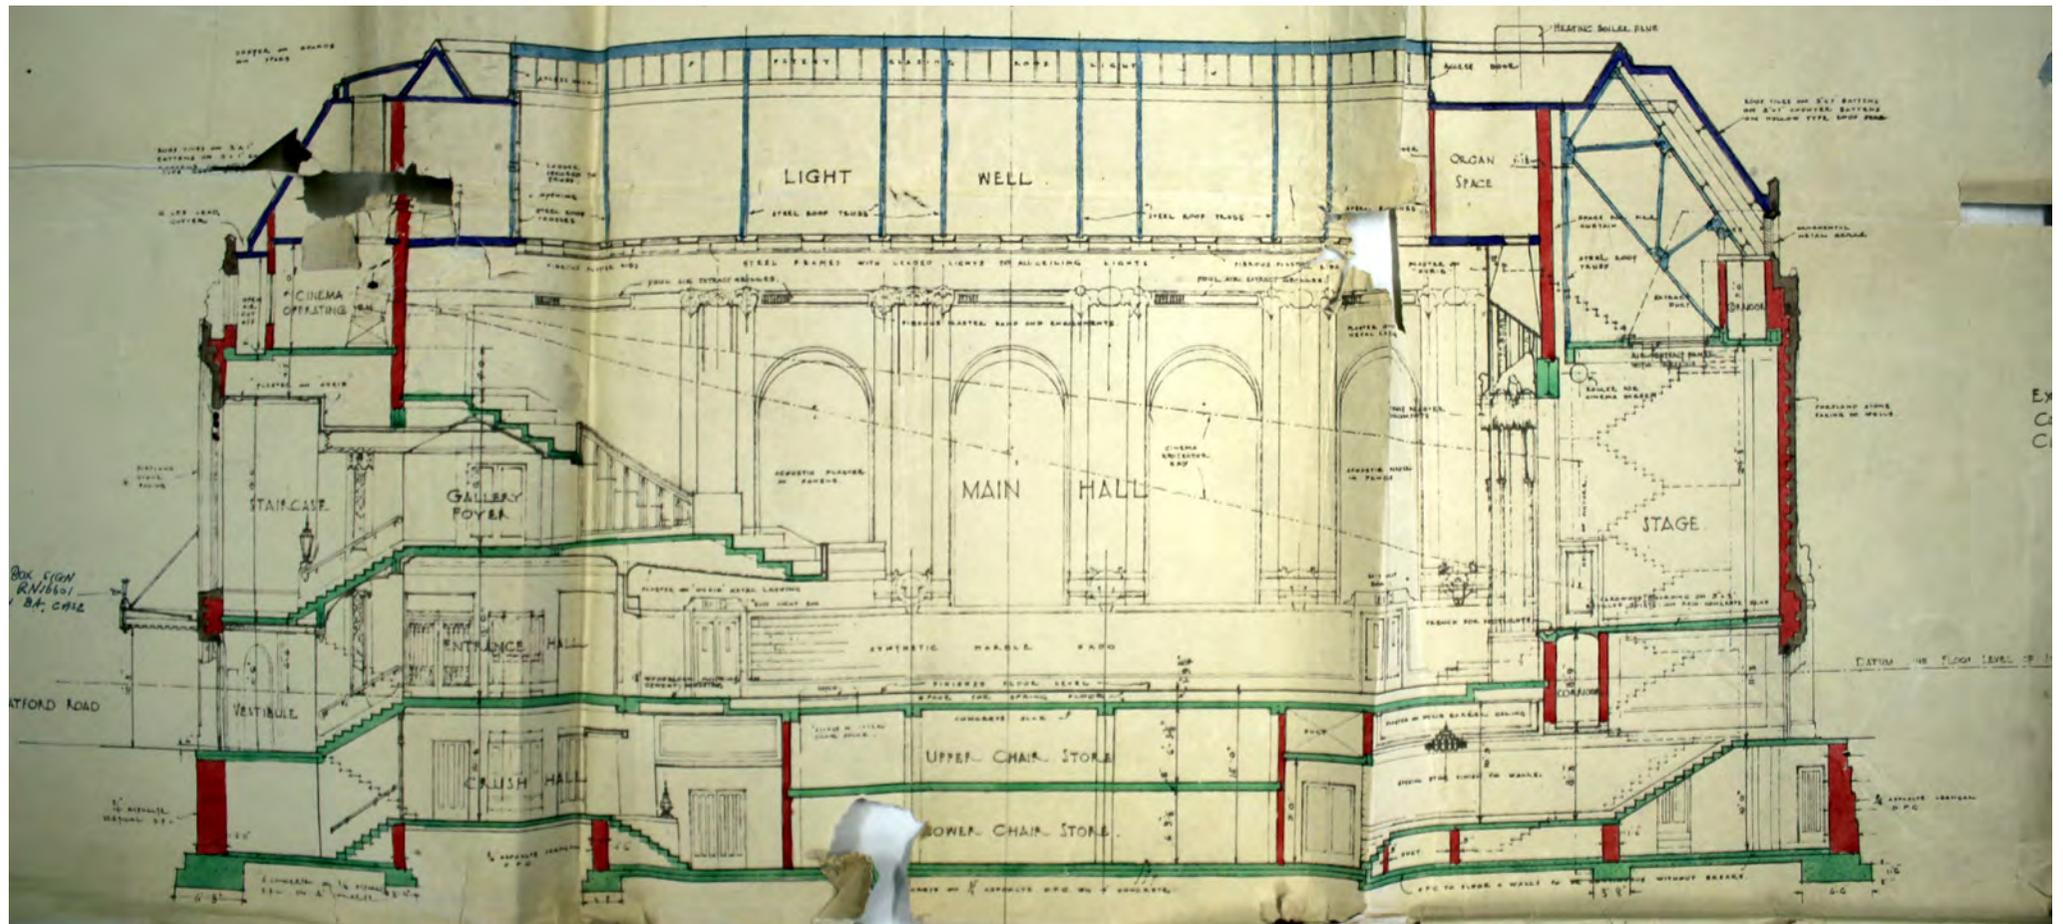
Hope's section through main hall and stage, 1930

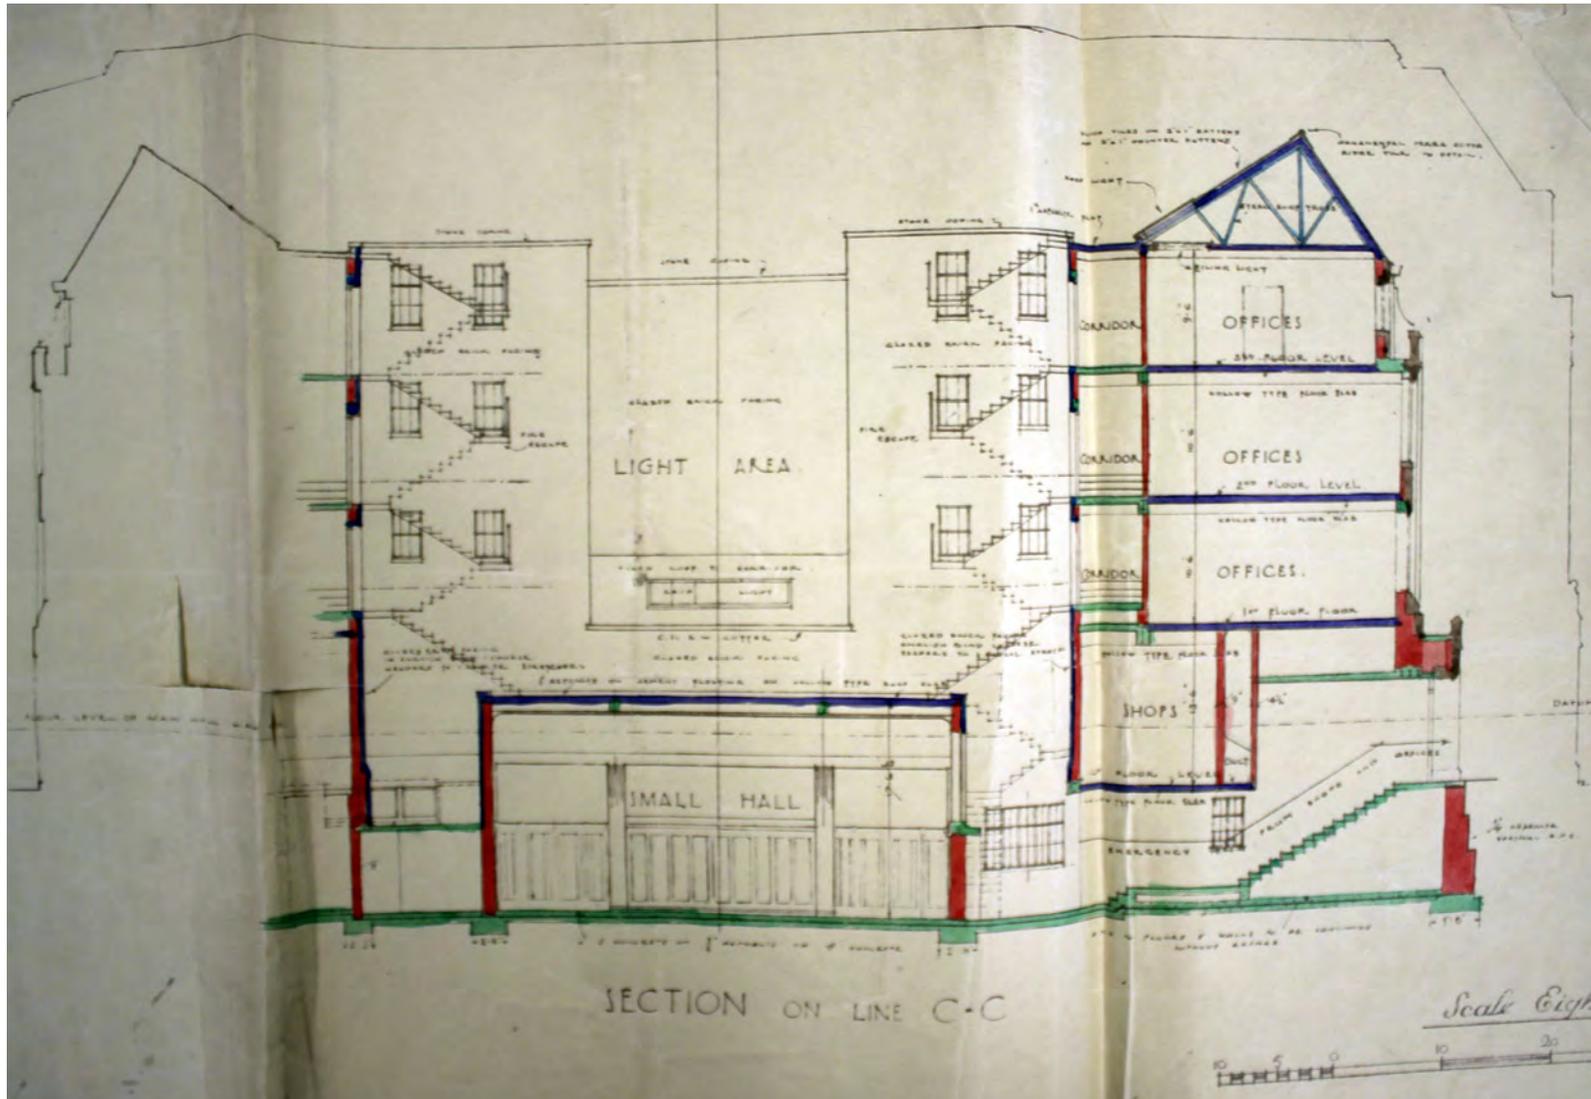
Hope's section of council offices, 1930

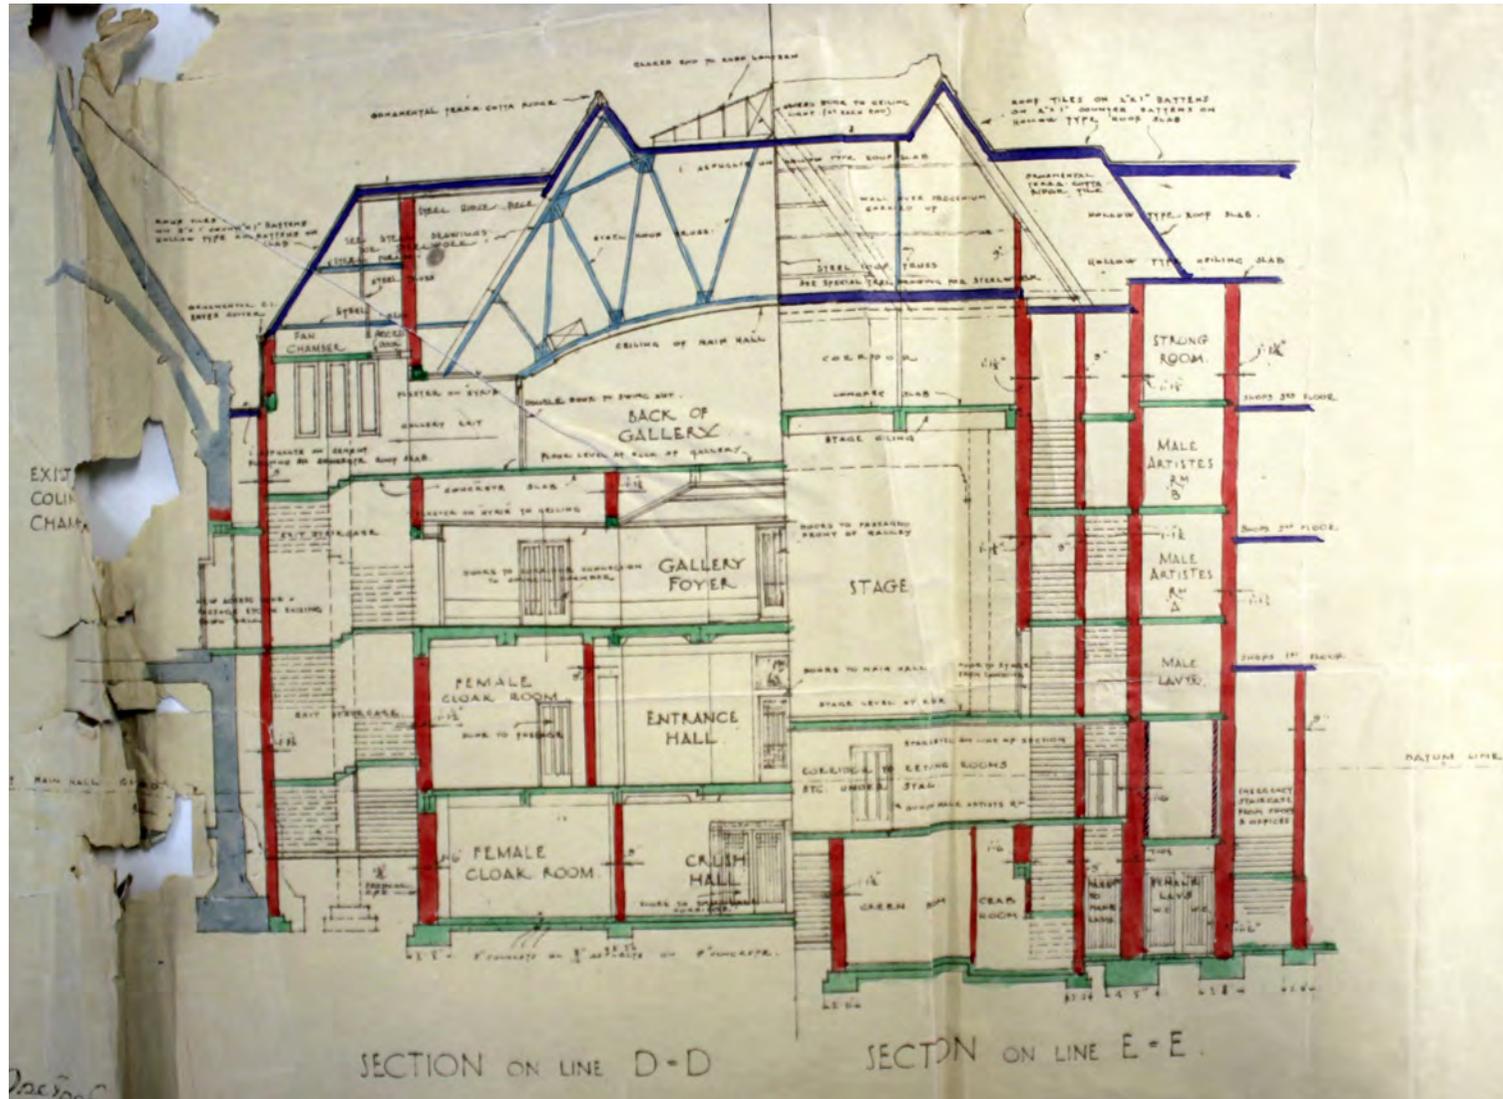
Hope's other section drawings, 1930

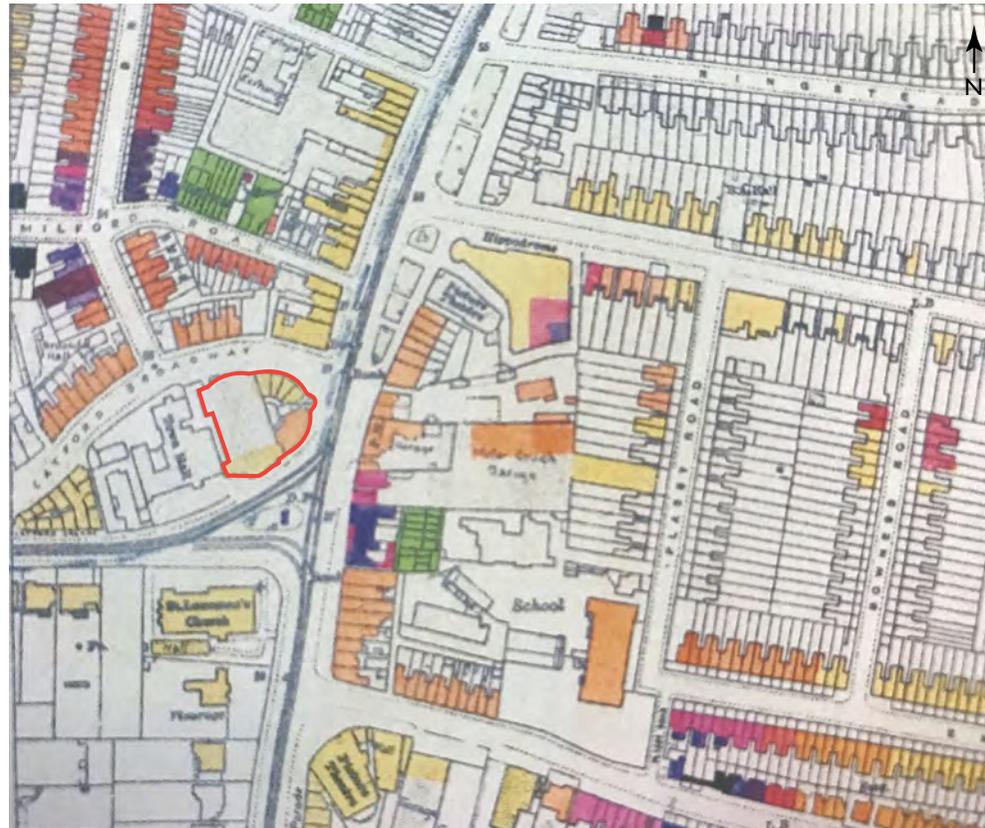
Bomb damage map. The orange colouration indicating that the building only suffered non-structural, minor blast damage.

Having only suffered minor and non-structural blast damage during the war, the building continued to function as an events venue for both concerts, theatre shows and amateur boxing and in 1947 the building hosted the World Concertina Championships.

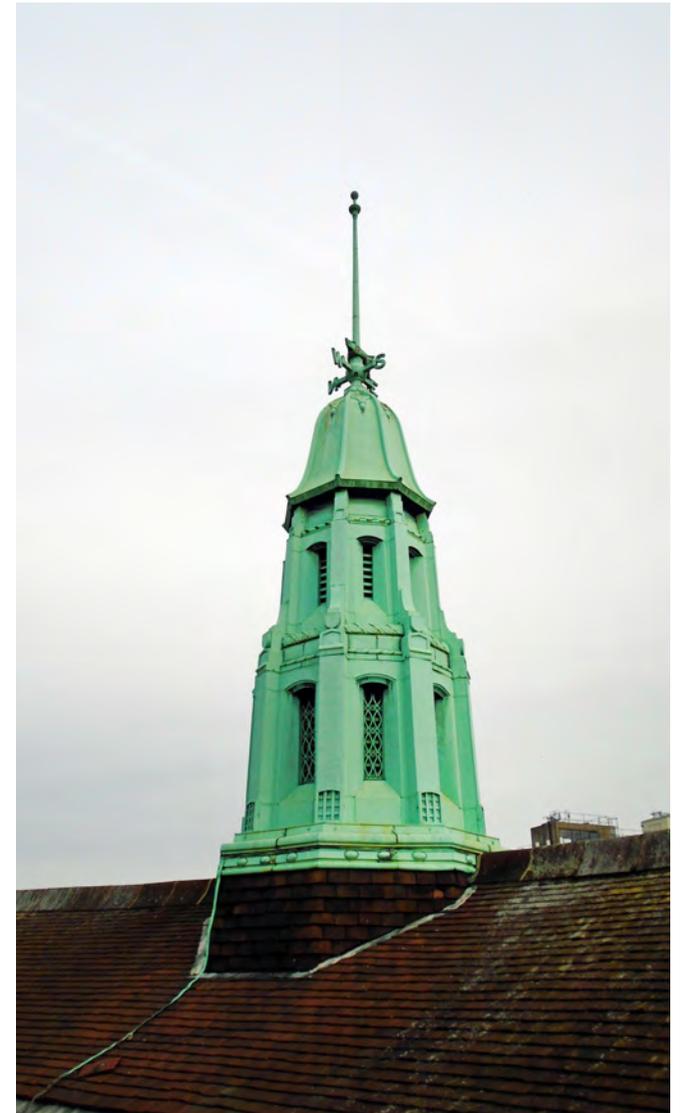
Two-storeyed steeple to the east side of the roof

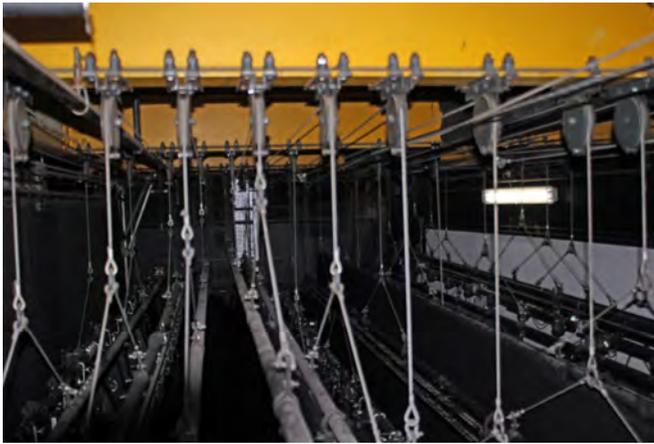
The scenery hangers, suspended from the I-Beams

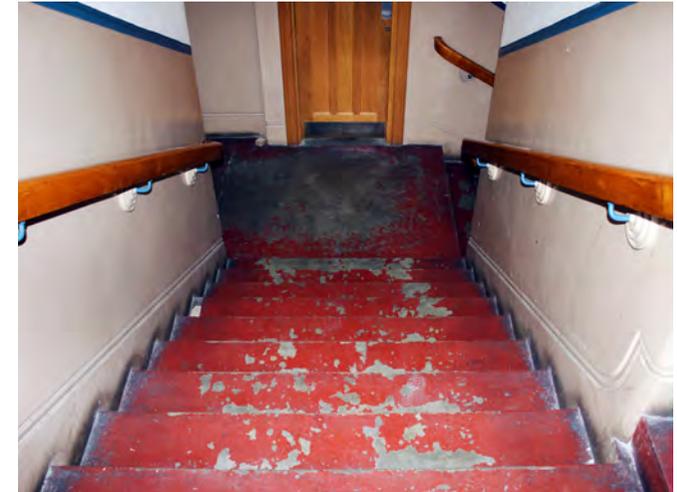
Deteriorated floor finish demonstrated in the back of house circulation space

The corridors which lead to the secondary fire escapes and back of house do not have the same level of decoration. In contrast, these corridors have a plain painted wall finish with a simple moulded detail at skirting and dado level, timber handrails and a worn painted concrete floor finish. The back of house circulation spaces are also in poorer condition compared to the front of house areas.

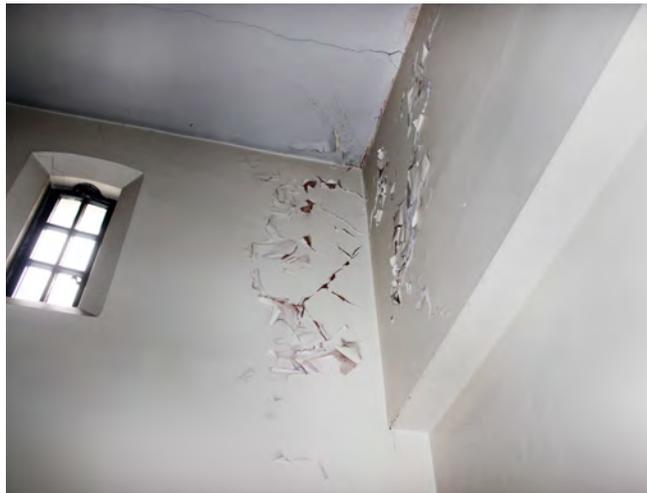
Areas of peeling paint within damp, poorly ventilated areas of the building

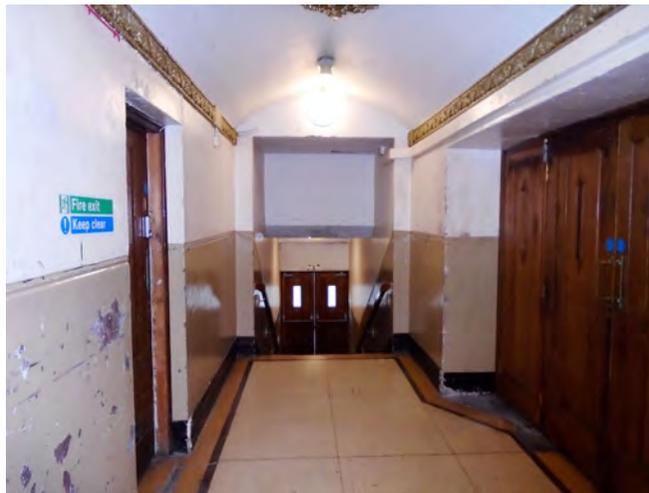
Back of house circulation spaces poorly kept with damage to wall and floor fabric

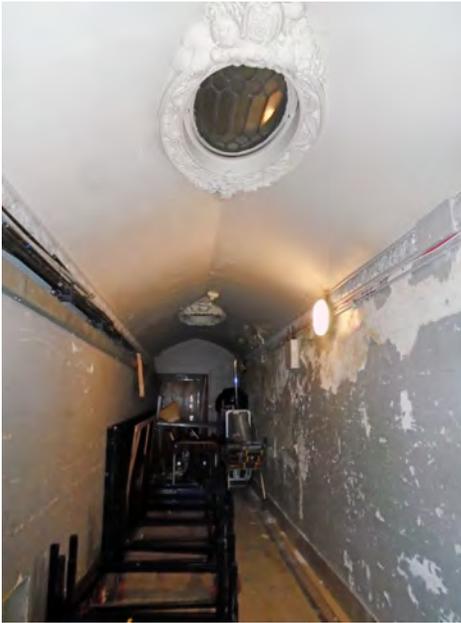
Linear corridor to the west of the concert hall is now being used as a storage area and is suffering from damp. The deterioration has caused for the paint finish to flake and detach, however, the moulded vent surround still remains intact.
