Conservation Comments

Reference number	DC/14/88305
Address and postcode	Rollins House, Excelsior Works, 53 to 57 Rollins Street SE15 1EP
Brief description	Redevelopment of Units A, B, C, D, Rollins House, Excelsior Works, Rollins Street SE15 1EP and surrounding hard standing to create a mixed use building comprising residential and commercial floorspace and associated new landscaping (Outline Application).
Case officer	Stephanie Gardiner

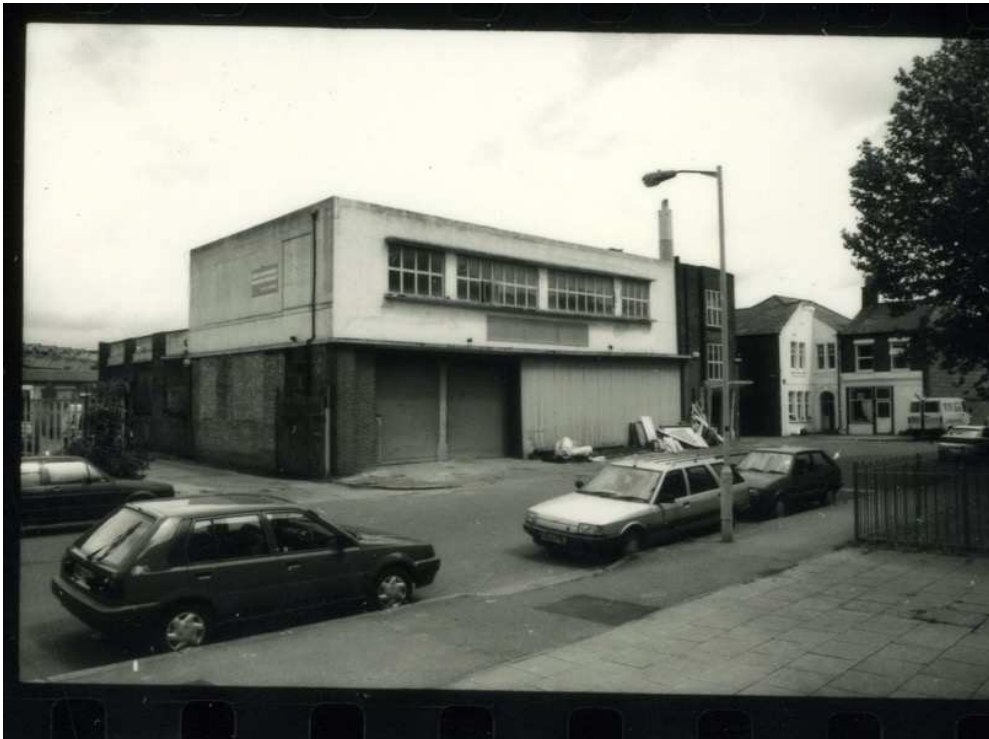
Image 1: Rollins House in 2001 (image supplied by Gabriella Kardos).

Unit A is the element which is strictly speaking Rollins House, originally office accommodation to the first floor and despatch on the ground floor. The other buildings occupy some of the former manufacturing parts of the site, known as the Excelsior Works.

4.0 Brief description of the building

This is a two storey building. To the front elevation the brick is rendered, as is the west flank elevation. The east flank elevation shows a change in brickwork from a higher quality red brick to a cheaper, paler Fletton brick. The building is flat roofed with a parapet. The building is of mixed construction. The brick elevations to the west, east and north are structural, but the building also has a reinforced concrete inner skeleton of columns and beams. A large beam is visible externally on the north elevation. There is also some use of structural rolled steel: a large beam is visible at first floor level in the stair tower. The first floor is believed to be shuttered concrete. There are two main elements: the main building to the west and an entrance tower to the east.

The entrance tower is in red brick and features a formal entrance consisting of a cantilevered reinforced concrete canopy, the doorway flanked by reinforced concrete mullions with stepped bases. There are small steel framed windows placed symmetrically either side of the doorway. Internally, at ground floor level there is an entrance area leading to concrete stairs in three flights. The stairs feature a graceful steel banister rail, which curves around the returns. This double height space is lit

by a large steel-framed skylight. The east flank wall features a blocked doorway and window at ground floor level. There is another blocked internal opening at ground floor between the lobby and the main building.

The main building was probably originally in four bays, with reinforced concrete columns lining up with those appearing as mullions on the first floor. Original doors or windows on the ground floor are lost, but it is believed that the two left hand bays formed vehicular entrances probably for goods in and out (see Image 1 above). First floor windows on all elevations have been replaced with white-painted aluminium double glazing; it is believed that the original windows were steel framed windows of the Crittall type. The windows on the south elevation are grouped into four bays, with three mullions between with some surviving indication of a tiled finish. There is floor scar evidence internally of the lightweight glazed timber screens used to divide the first floor into smaller offices. The main building has strong horizontal accents in the form of plain projecting reinforced concrete cornices. There is a bold cornice above the ground floor doors which wraps around the west flank elevation and is continued, after the stair tower, onto the east flank elevation. The cills and lintels of the first floor south elevation windows are formed by similar cornices of smaller dimensions. The north elevation is a mix of brick and concrete, with window cills here and elsewhere formed from plain canted brick.

To the north there was (until around 2003) a manufacturing shed. The steel rafter ends can still be seen in the reinforced concrete beam on the north elevation of Unit A. The east elevation of Unit A shows several areas of toothed brick; these are an odd feature, it may be that the builders intended to leave open the possibility of further extension to the east or that these are ornamental.

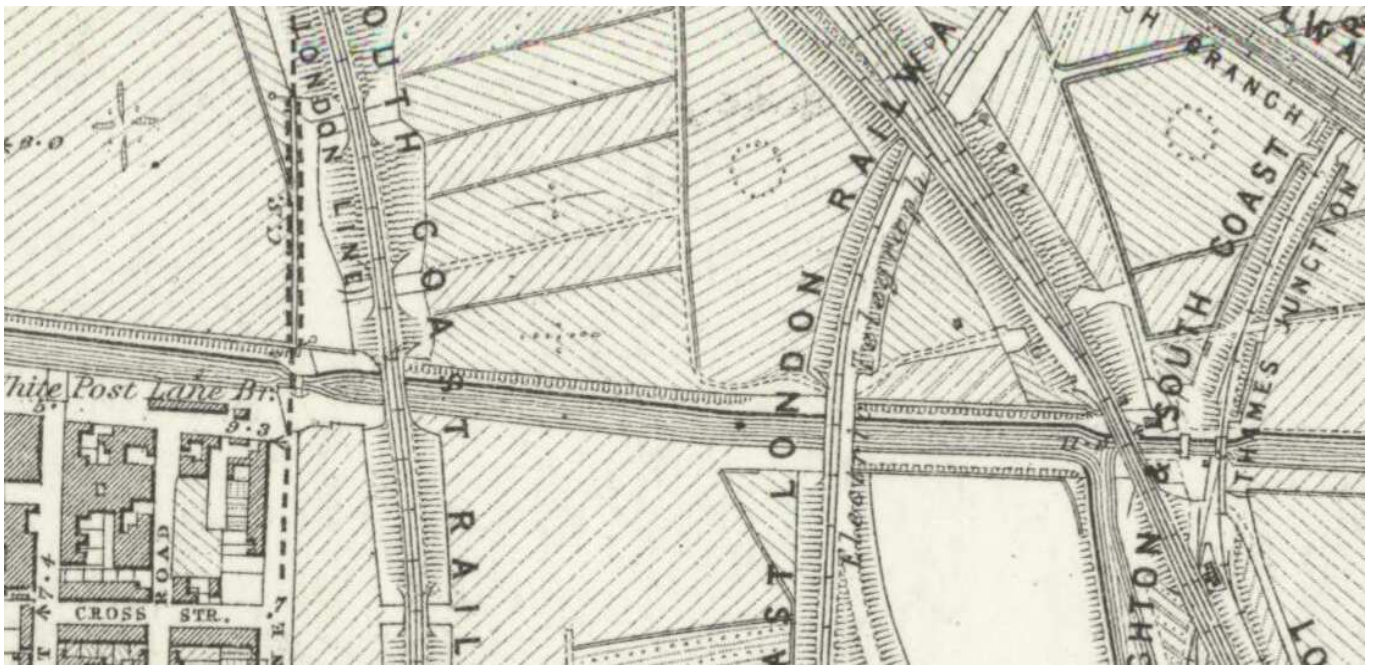
Image 2: 1867 Ordnance Survey Map. This shows the canal and the local railways in place but no development in the area, which was presumably still farmland.

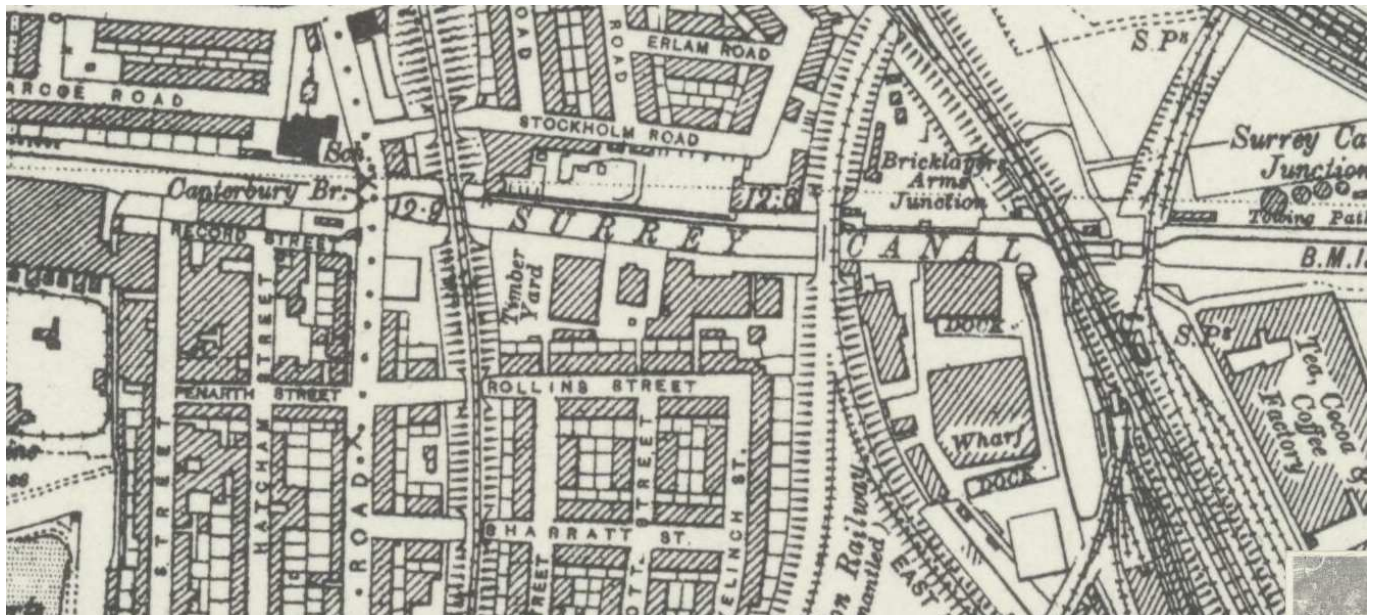
Image 5: 1938 Ordnance Survey Map. This shows houses (numbers 53 to 57 (odd) Rollins Street) on the site of Rollins House with buildings for the Excelsior Works behind.

The map progression above allows a fairly precise dating for Rollins House itself. The building was not there in 1938 or 1945 but appears in 1950. The building was therefore constructed between 1945 and 1950. Given the disruption of the building industry and lack of building materials caused by the Second World War, it is likely to have been built between 1947 and 1950.

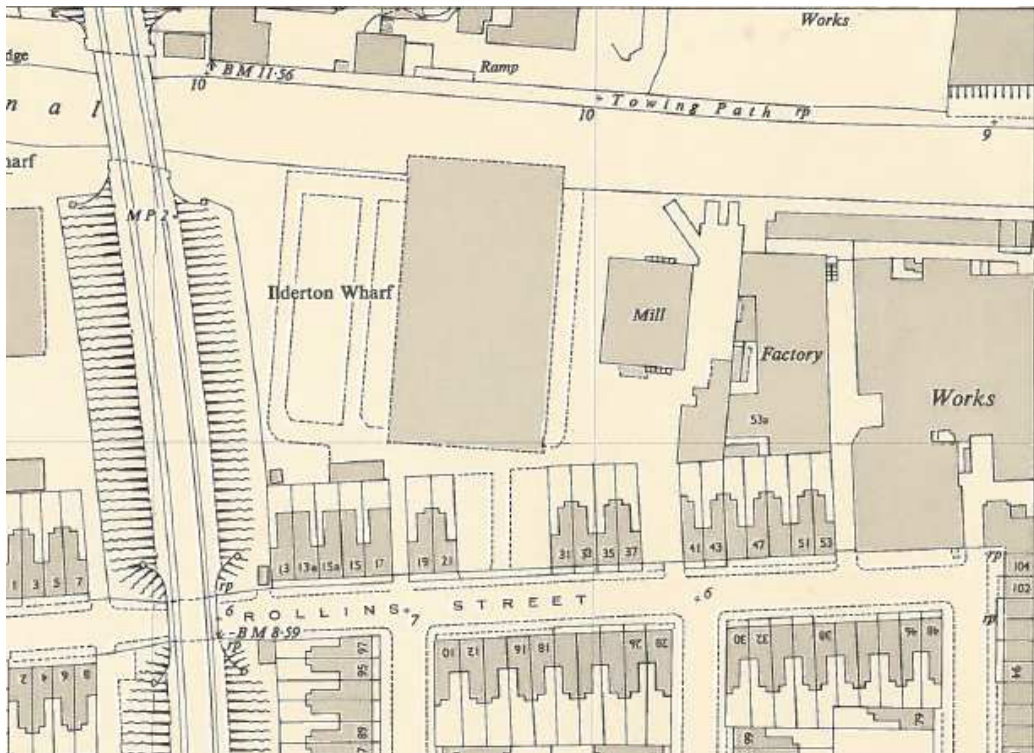
Image 8: 1961 Ordnance Survey Map. Few significant changes.
