Structural Engineering Inspection Report

79 Chinbrook Road, London SE12 9QL

Project No. 9360

13 April 2016

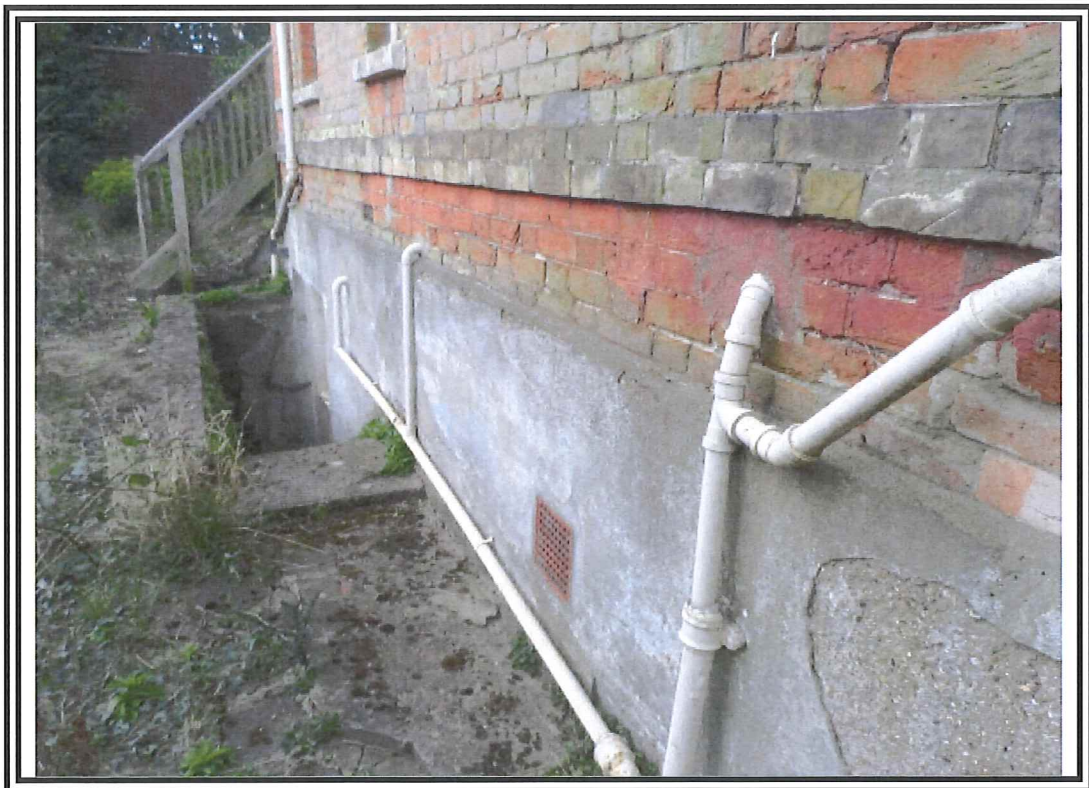
Photo 4:

- 2.6 External access to the basement is via concrete steps within a stairwell formed by retaining walls to the rear of the property. See photograph 4. Internally, the basement is accessed via timber stairs. At the time of our visit, sections of stair tread were missing and there was a sign warning of unsafe flooring. Based on this and the lack of lighting, we did not inspect the basement during our visit.

- Underpinning to the internal spine walls on either side of the entrance hall to ensure these are supported by a competent bearing stratum.
 - Provision of safe access into the basement area so that an inspection can be undertaken and any defects noted as these may have a bearing on other areas.
