Committee	PLANNING COMMITTEE (A)	Item No. 11
Report Title	5 ABERDEEN TERRACE SE3 0QX	
Ward	Blackheath	
Contributors	Regina Jaszinski	
Class	PART 1	Date: 11 NOVEMBER 2010

### **Unauthorised works to a Listed Building**

The painting of the stucco detailing and render at the front, side and rear elevation and the painting of the terracotta elements of the front elevation without listed building consent

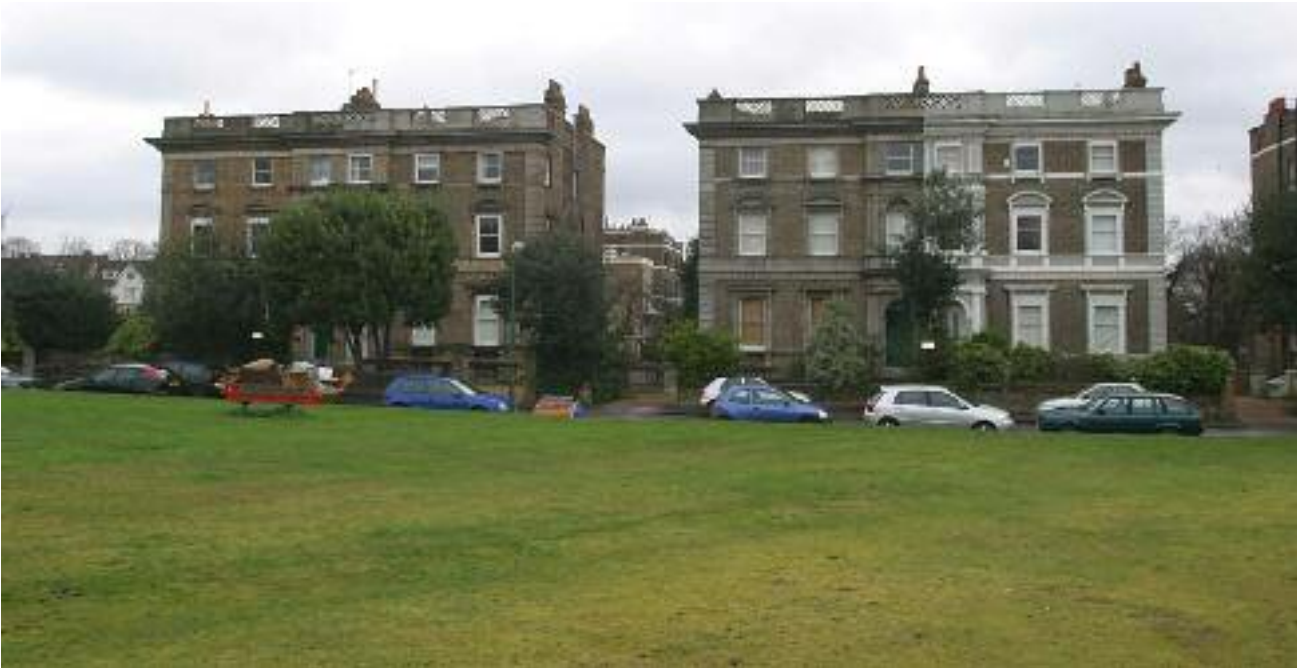
From left to right: No. 6 & 5 and 4 & 3 Aberdeen Terrace before works were carried out, date unknown (before May 2009, photograph submitted by the agent for a LBC application in 2009)

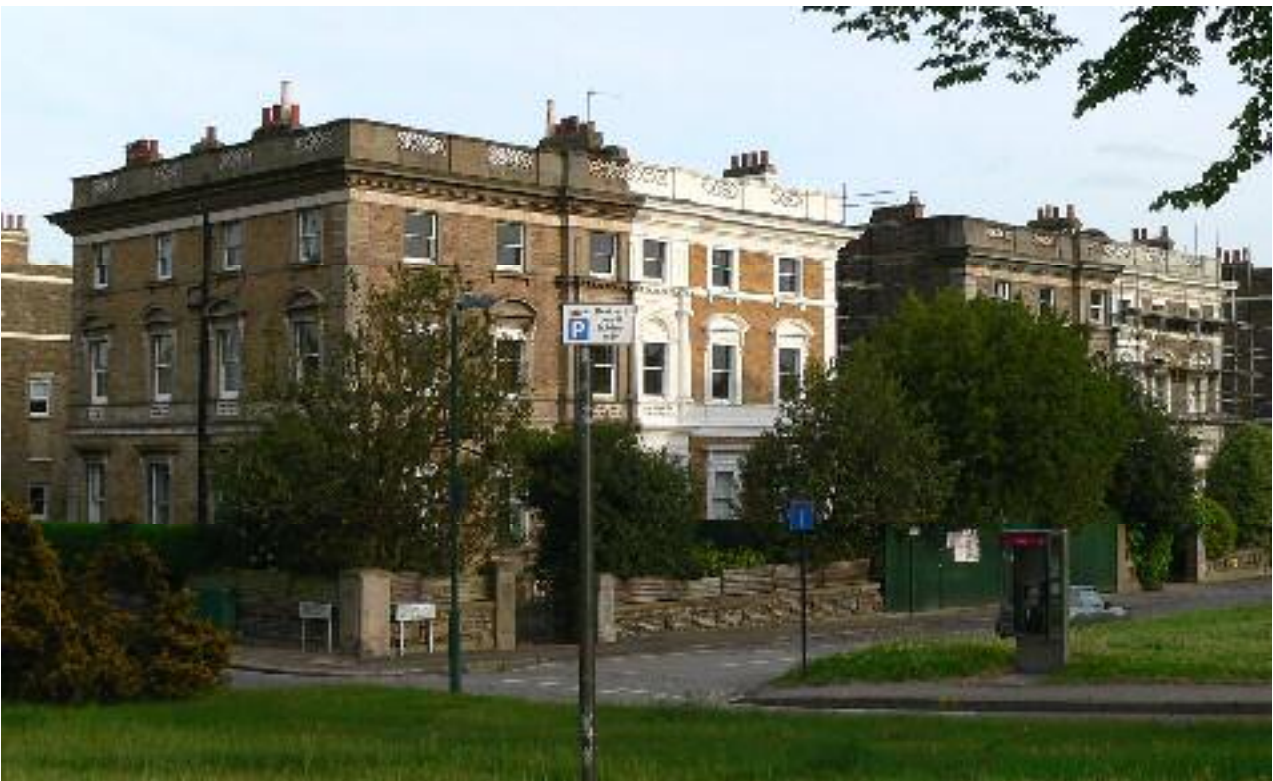
No. 5 (right) and No. 6 (left) Aberdeen Terrace (photograph taken 5.05.2009)

- 3.1 At a site visit on 7 May 2009 Officer noted that the external stucco and terracotta architectural elements had been painted over with a white paint. The stucco was originally of a natural light beige colour meant to imitate stone. It had over time weathered to the pale grey. The terracotta elements were unglazed and showed colour variations from buff to a pale pink and orange, which is typical for the London clay that has been used for their production.
- 3.2 The painting of architectural embellishments, where these were not originally painted, would require Listed Building Consent. It is unlikely that an application for consent to retain the paint would be approved, mainly because of its detrimental impact on the appearance of the listed building and the unity it forms with No. 6 and the group as a whole.

- 5.4 Each pair of semi-detached houses were designed to appear as one grand villa. The paint at No. 5 now creates a stark contrast to the natural, aged colours of the elevations of No. 6 and the other houses. This effect is made stronger due to the brickwork of No. 5 having been over-cleaned. As a result, the white paint detracts from the entity the building forms with No. 6 and has a detrimental effect on the character of these group of buildings as whole. The building now stands out harshly from the rest of the group, destroying its uniformity.

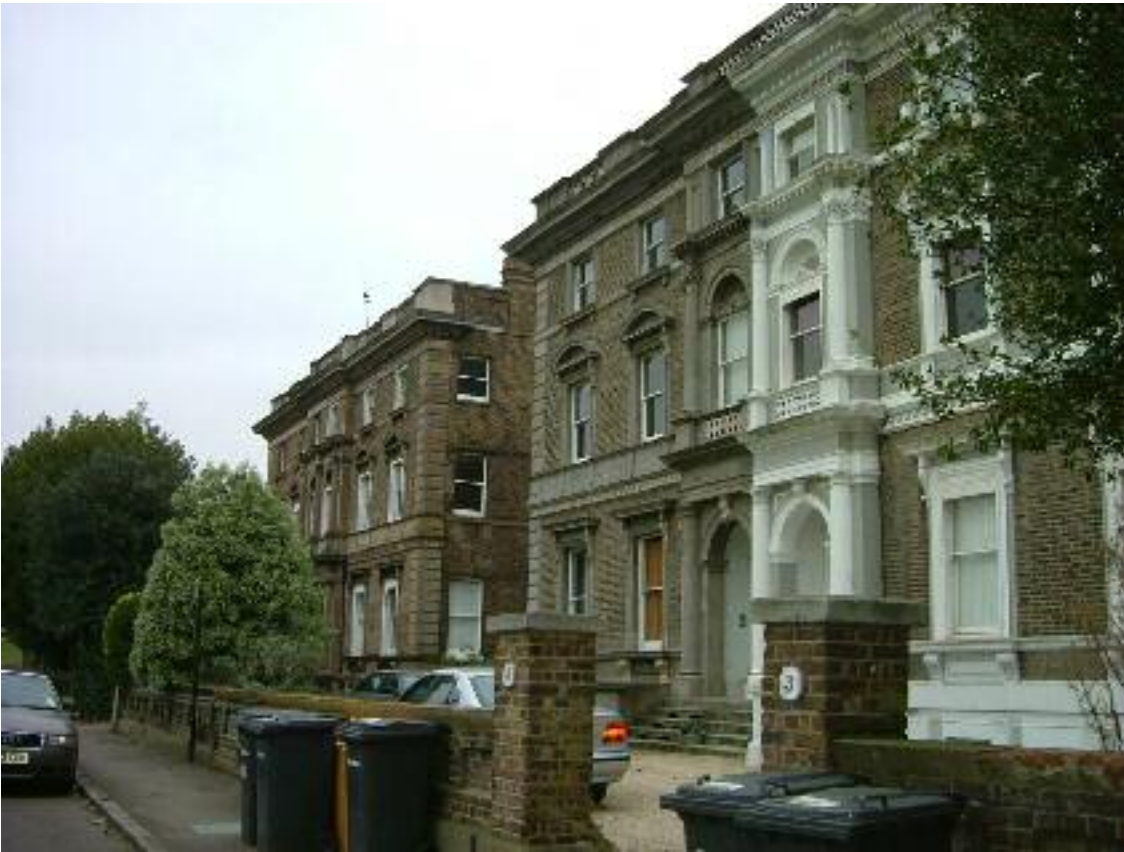
No. 3 & 4 (right) and 5 & 6 Aberdeen Terrace before painting and cleaning of No. 5, picture taken in February 2006

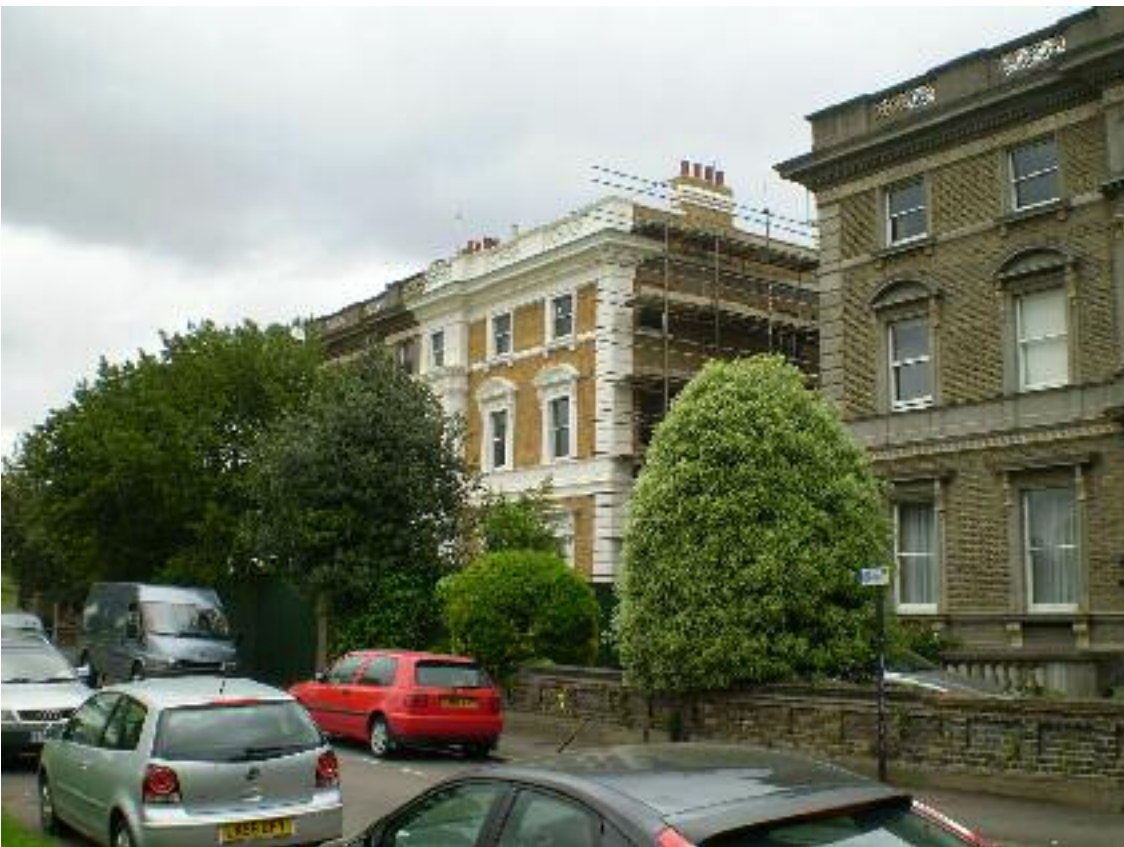
No. 5 Aberdeen Terrace after painting and cleaning, photograph taken 9.05.2009

- 5.5 Prior these works, the appearance of the building was determined by the natural colours of rather subtle differences of the stone-imitating stucco, the yellow brick and the buff coloured terracotta. Under the layer of paint, the difference between the stucco and the terracotta elements is entirely lost, and as a result the architectural detailing has lost definition and depth. Details, such as the Vitruvian scroll motif on the stucco frieze between the raised ground floor and first floor are hardly any longer noticeable in a flat sea of White.

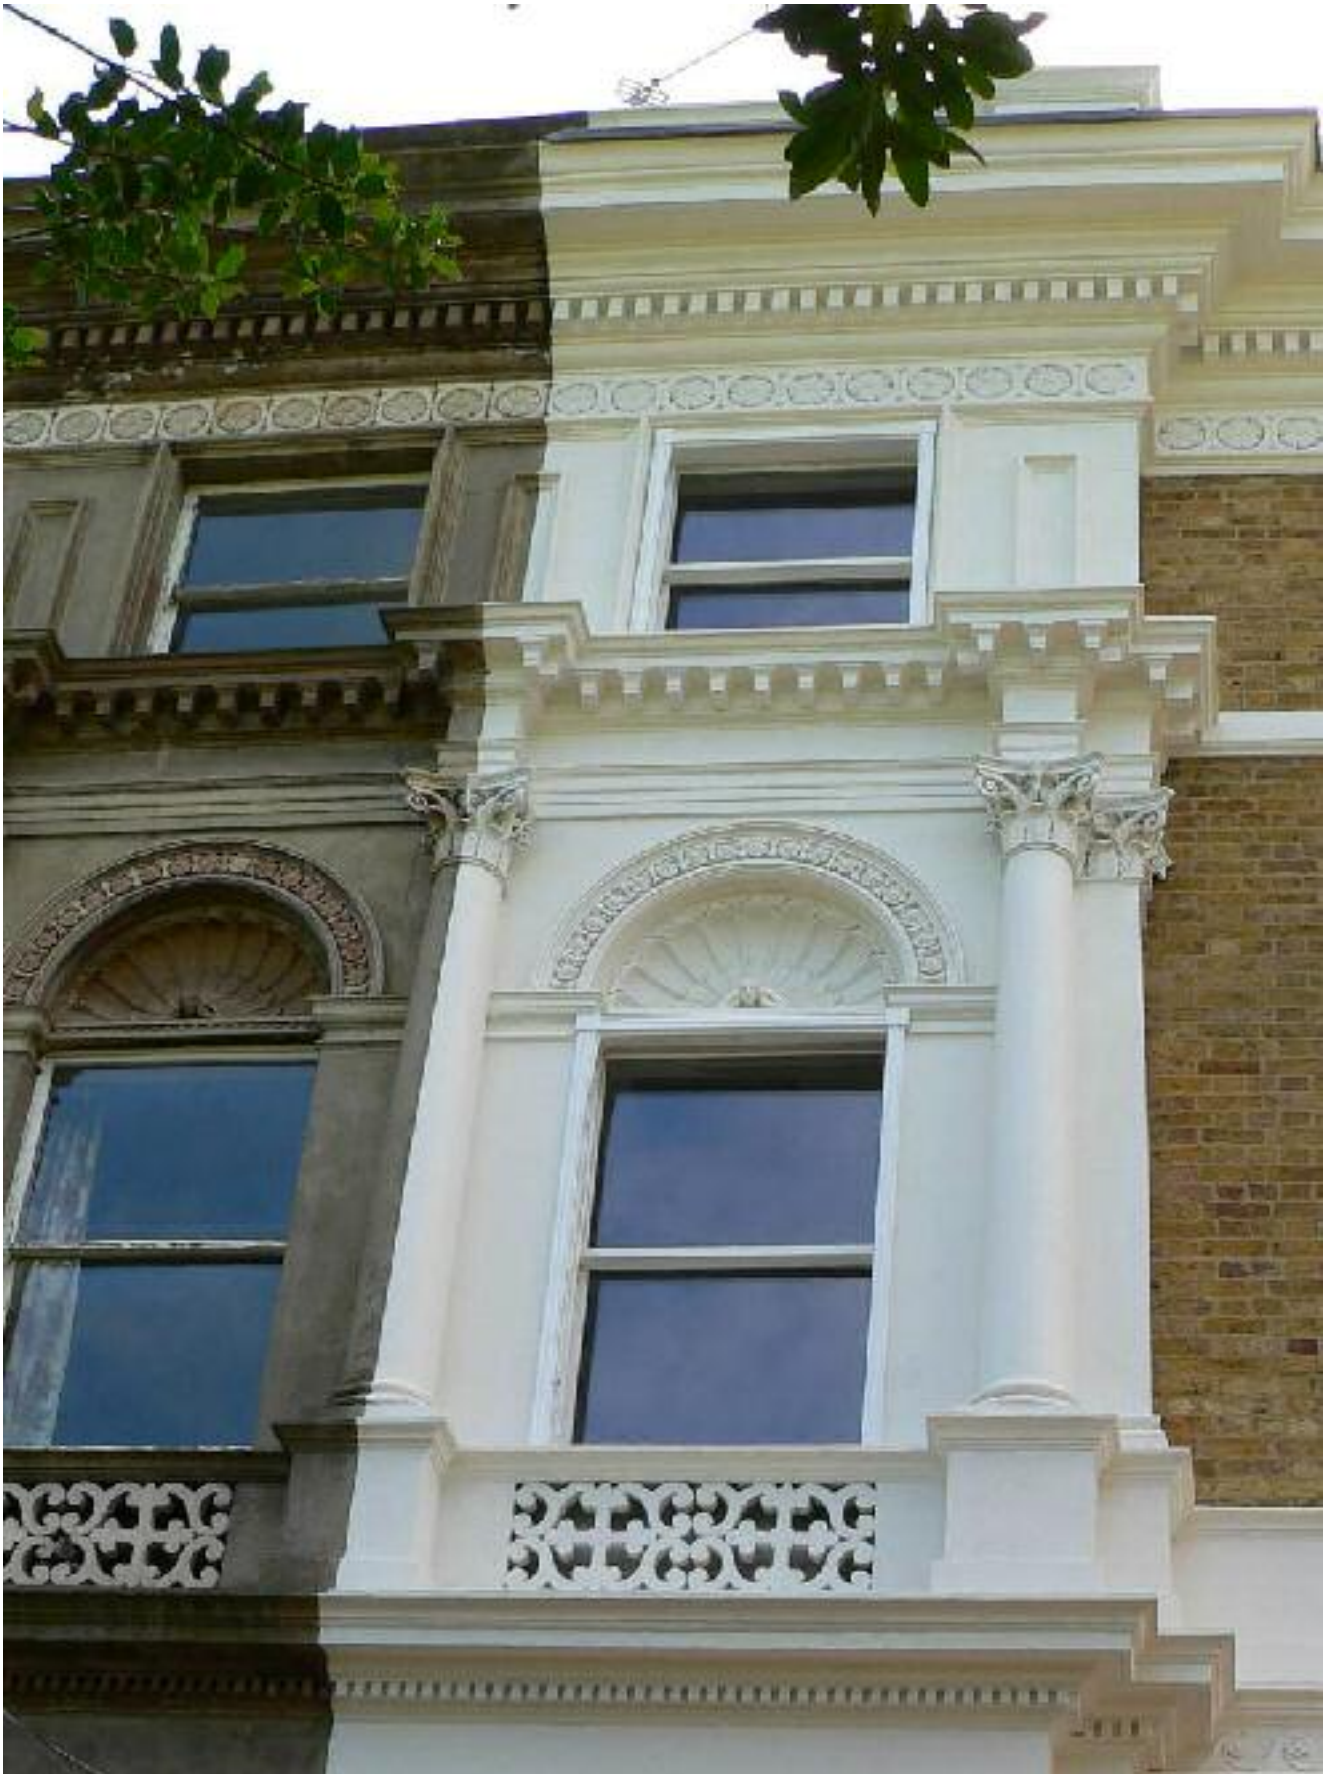
Nos. 5 & 6 Aberdeen Terrace, detail of the projecting entrance bay (photo taken 17.6.2009)

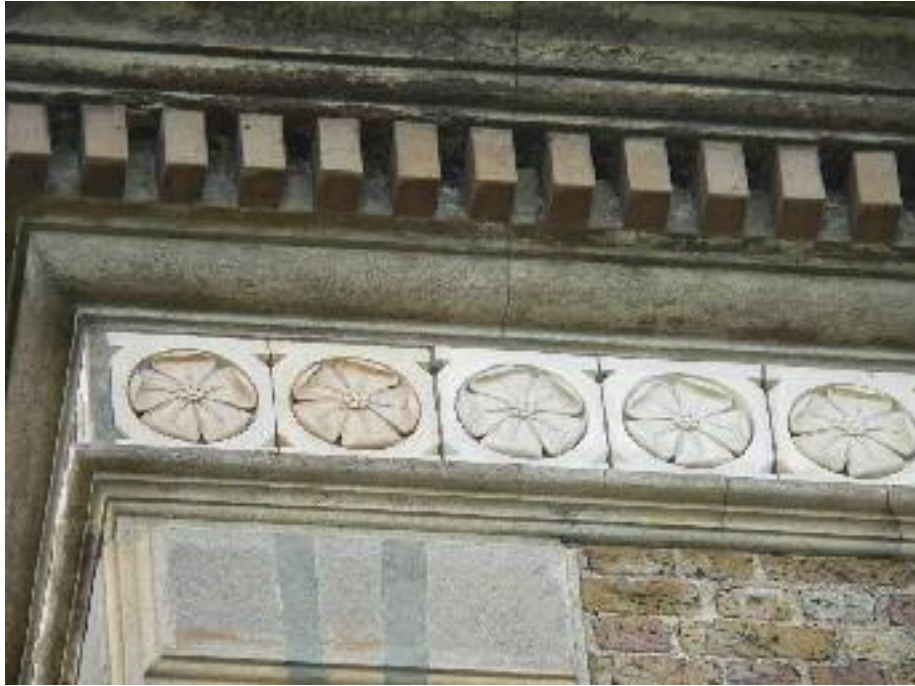
Terracotta Rosette Frieze, stucco quoins and moulded dentilled cornice at No. 6 Aberdeen Terrace (photo taken 7.10.2010)

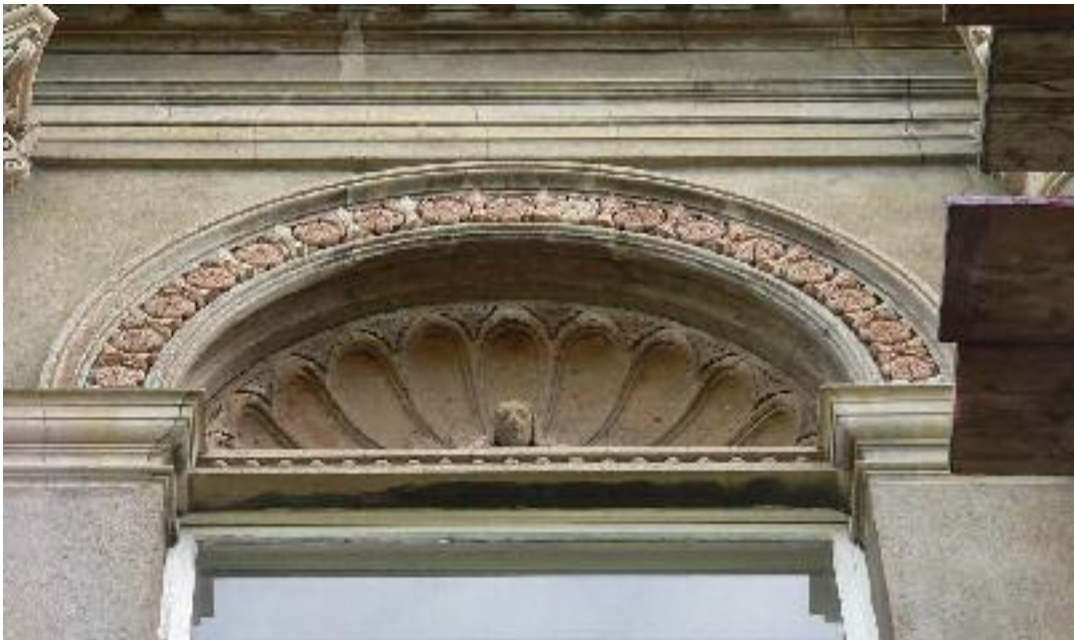
Stucco and Terracotta detailing of the fan moulding at the central bay to No. 6 Aberdeen Terrace (photograph taken 7.10.2010)

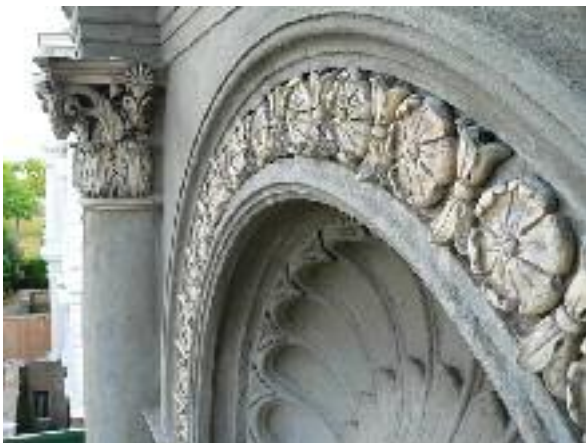
Terracotta Rosette frame surrounding the fan moulding at No. 4 Aberdeen Terrace (photograph taken 10.7.2010)

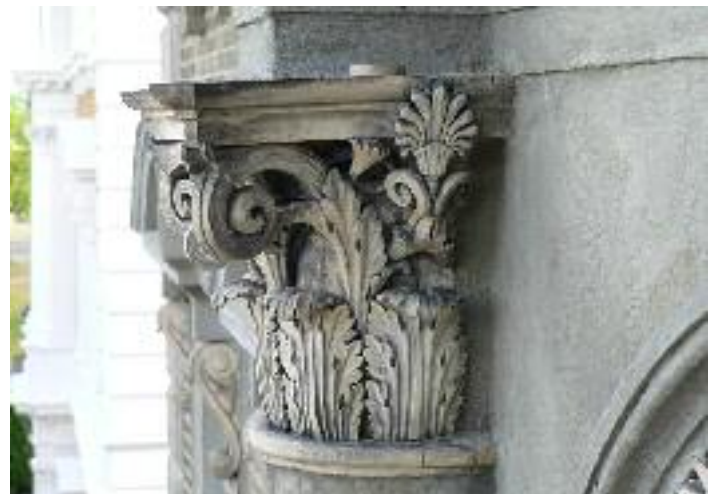
Terracotta Corinthian capital at No. 4 Aberdeen Terrace (photograph taken 10.7.2010)

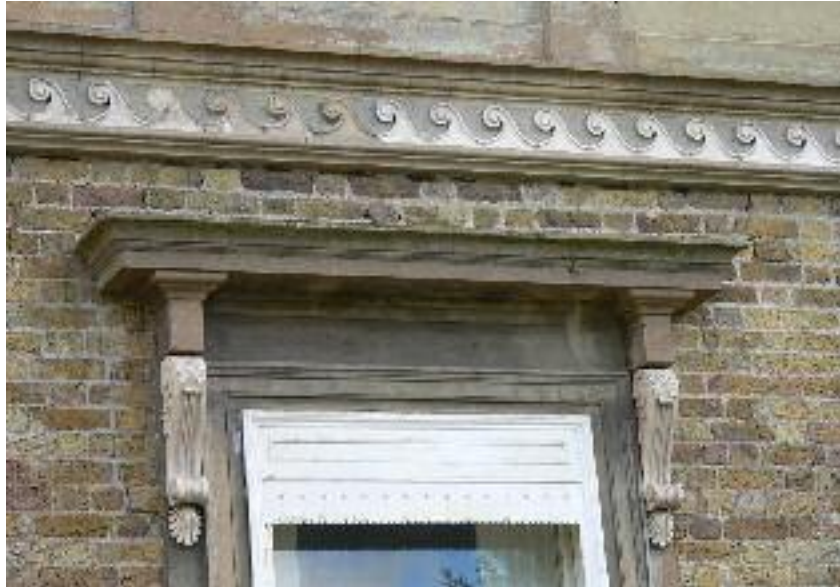
Stucco window surround with terracotta consol brackets and stucco frieze above with Vitruvian Scroll ornament at No. 6 Aberdeen Terrace (photograph taken 7.10.2010)

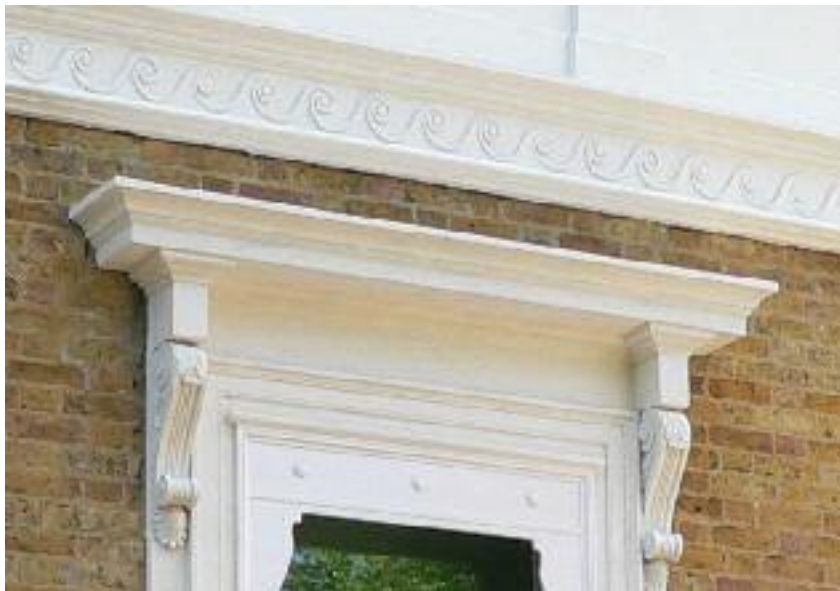
Stucco window surround with terracotta consol brackets and stucco frieze above with Vitruvian scroll ornament at No. 6 Aberdeen Terrace (photograph taken 17.6.2010)

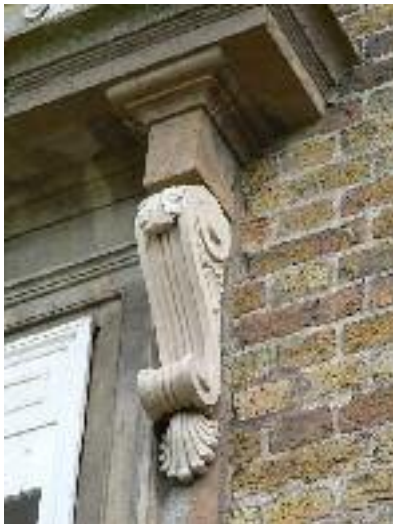
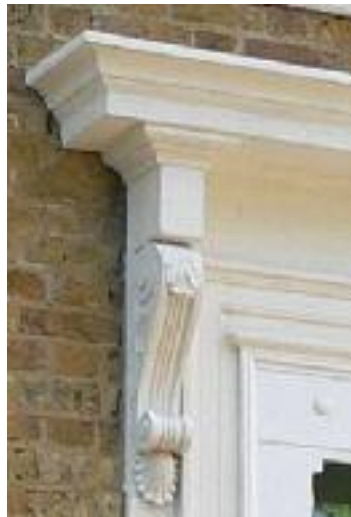
Consol bracket to window architrave, detail at No. 6 Aberdeen Terrace (left) and painted over at No. 5 (right).

- Removal of the paint from the stucco elements,
- Removal of the non-matching stucco repairs and replace with stucco matching in texture and colour the (newly cleaned) original.
- Repairs to the stucco as necessary where the application of paint and subsequent removal has caused damage.

- Removal of paint from the terracotta elements;
- Repairs to the terracotta elements as necessary where the application of paint and subsequent removal has caused damage.

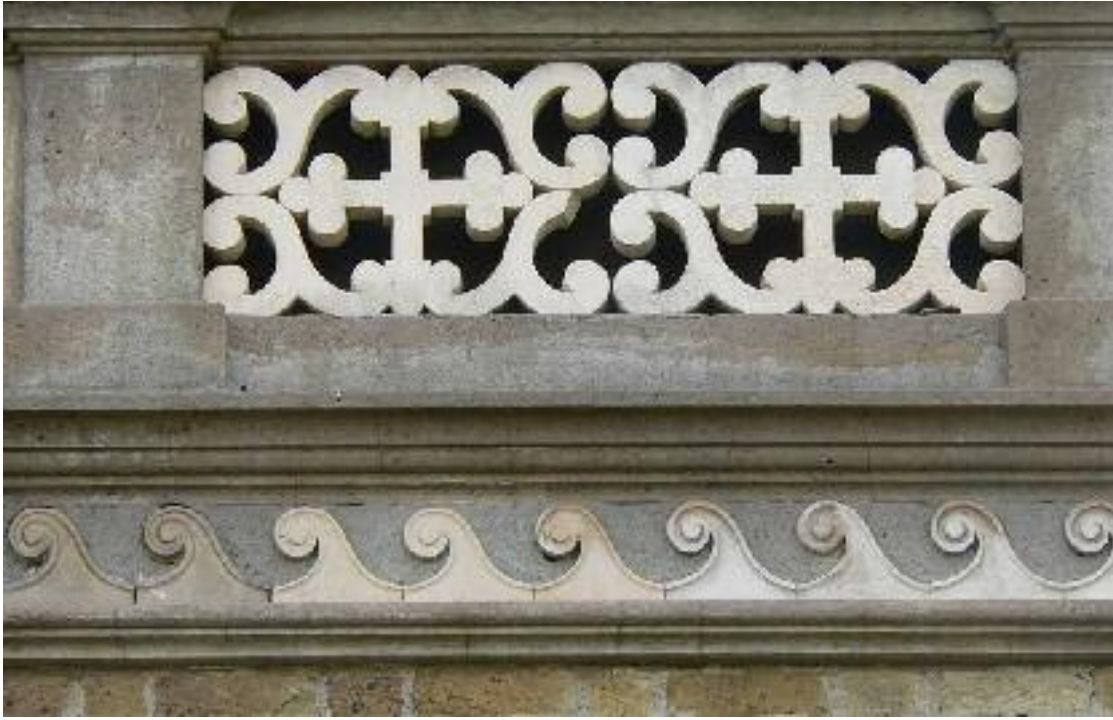
Stucco frieze with Terracotta Vitruvian scroll ornament and Terracotta balustrade above, detail at Aberdeen Terrace No. 6 (photograph taken 7.10.2010)

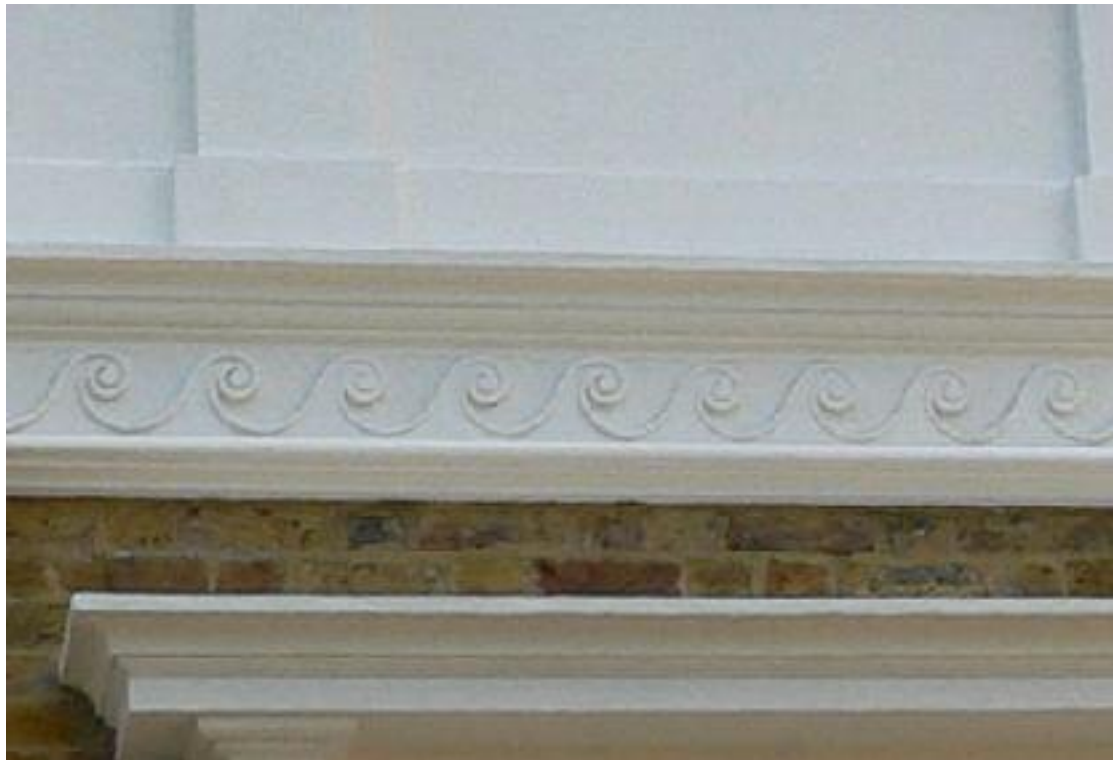
Stucco frieze with Terracotta Vitruvian scroll ornament painted over, detail at Aberdeen Terrace No. 5 (photograph taken 17.6.2009)
